# DALY RIVER CATCHMENT

### An Assessment of the Physical and Ecological Condition of the Daly River and its Major Tributaries

Technical Report No TR99/10

**July 1998**

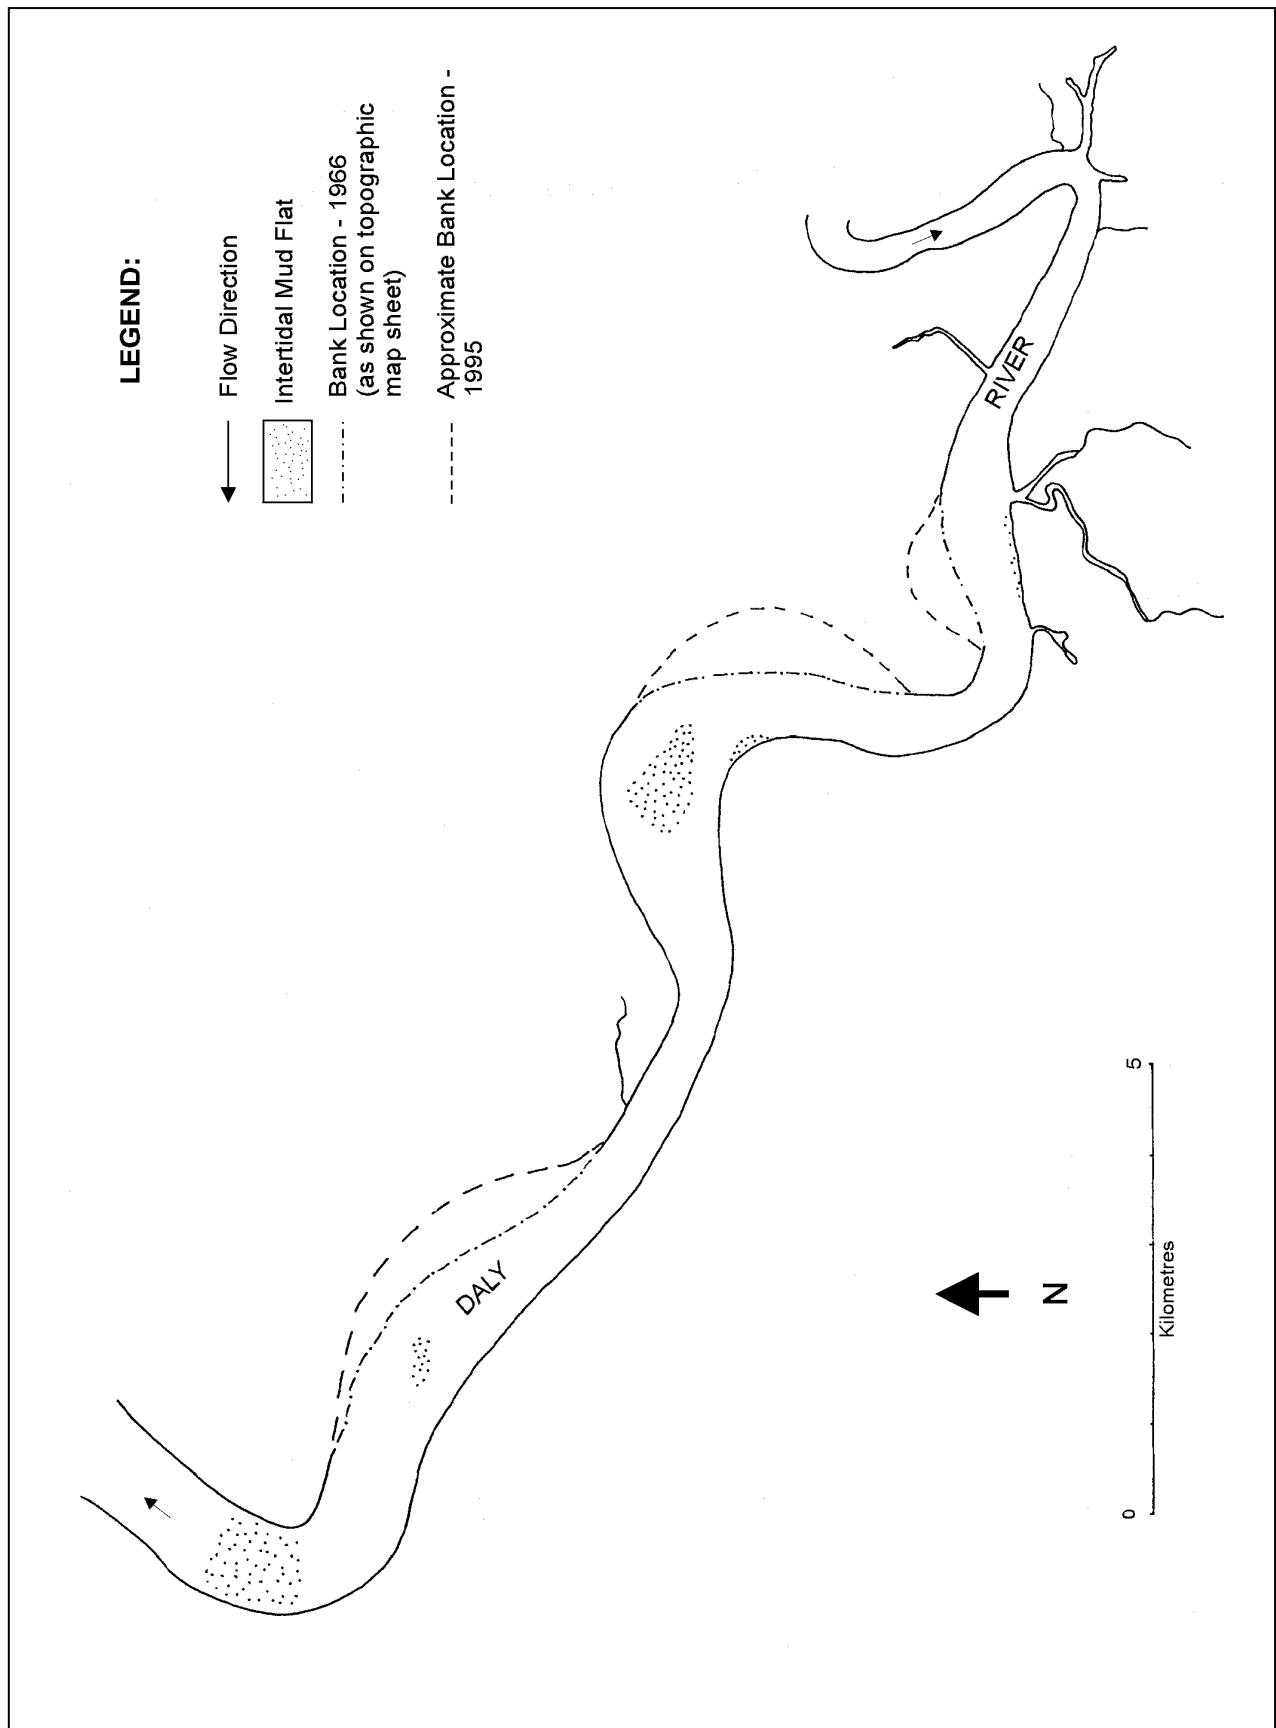
Figure 5.1 Changes in Channel Location along the Lower Tidal Section of Daly River

Downstream of site 1a/8 there were several outside bends that are migrating and the banks have eroding >1km since the topographic maps were produced in 1966. The banks along these sections are actively eroding and, as they collapse into the river, so does the riverine vegetation, which consists mostly of mangrove species. Refer Section 2.7 and Appendix A, which discusses the 'Evolution of the Daly River Estuarine Plains, noting how the river meanders along the tidal section of the Daly River are very actively migrating and the channel is "ever-changing".

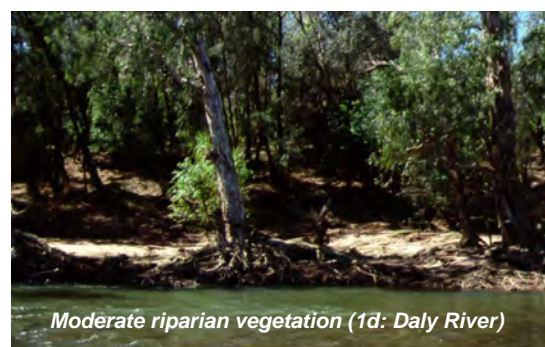
Moderate riparian vegetation (1d: Daly River)

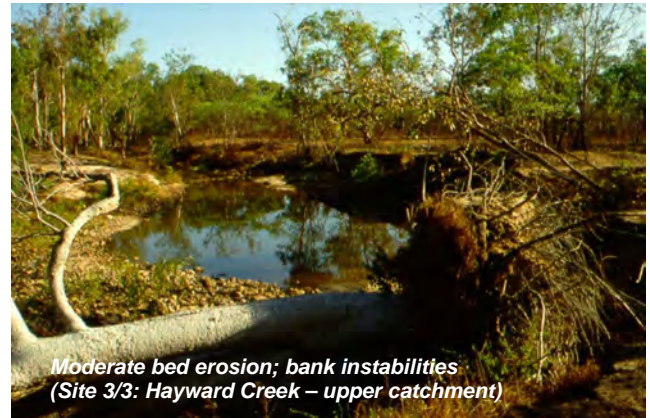
Poor creek crossing and track design and maintenance, or lack thereof, can influence the condition of creeks at a local scale, as has been shown in the upper catchment site. This emphasises the importance of properly locating creek crossings, avoiding outside bends or steep banks, and targeting areas where the creeks are shallower and have larger sediments along the bed like gravels, cobbles or boulders. As little riparian vegetation should be disturbed as possible when constructing creek crossings. Tracks should be maintained on a regular basis and should not concentrate flows along their lengths as was occurring in this upper catchment site.

Moderate bed erosion; bank instabilities  
(Site 3/3: Hayward Creek – upper catchment)

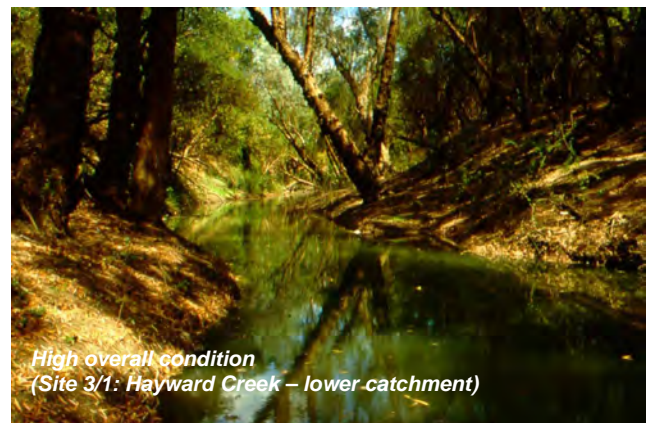
High overall condition  
(Site 3/1: Hayward Creek – lower catchment)

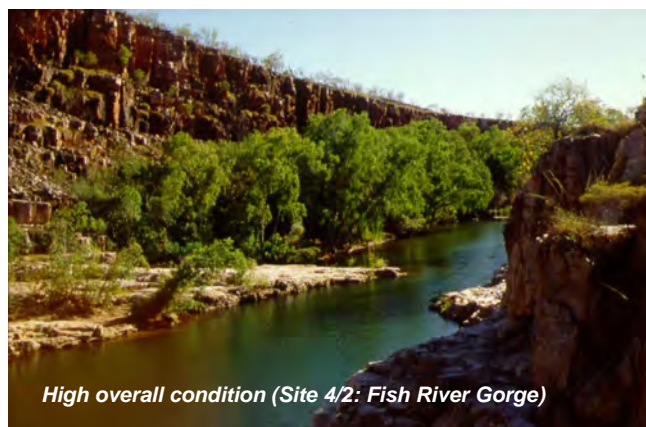
High overall condition (Site 4/2: Fish River Gorge)

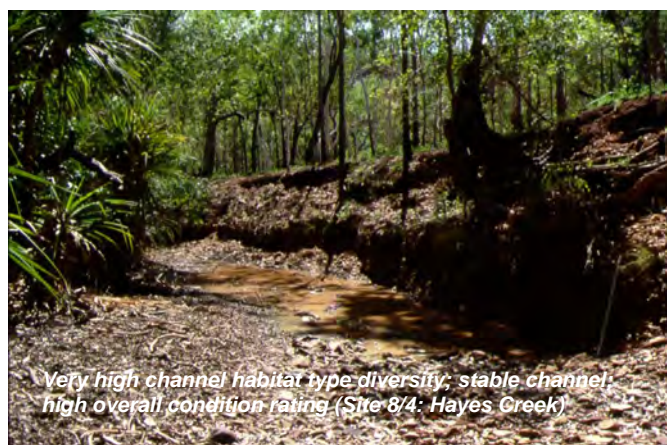
Very high channel habitat type diversity; stable channel; high overall condition rating (Site 8/4: Hayes Creek)

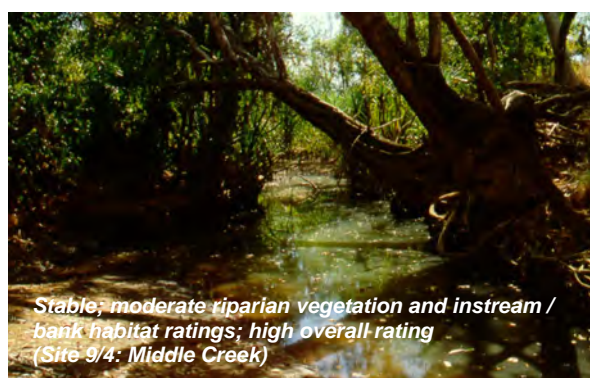
Stable, moderate riparian vegetation and instream / bank habitat ratings; high overall rating (Site 9/4: Middle Creek)

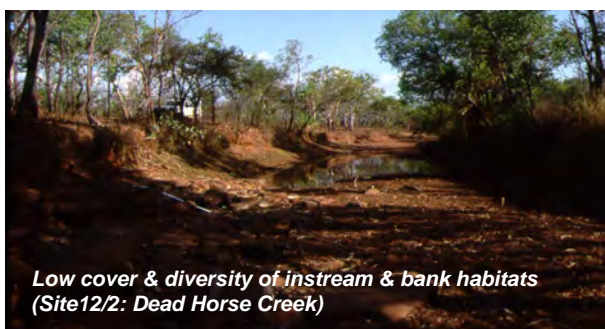
Low cover & diversity of instream & bank habitats  
(Site12/2: Dead Horse Creek)

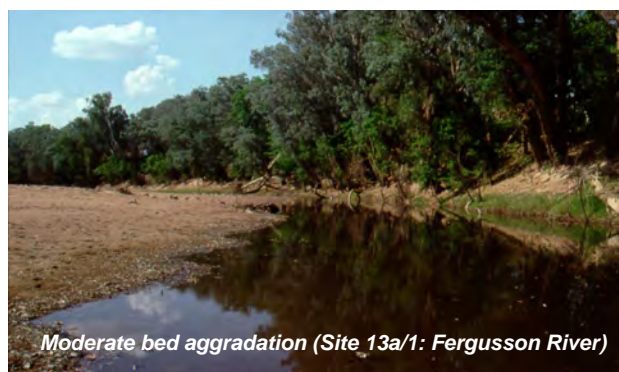
Moderate bed aggradation (Site 13a/1: Fergusson River)

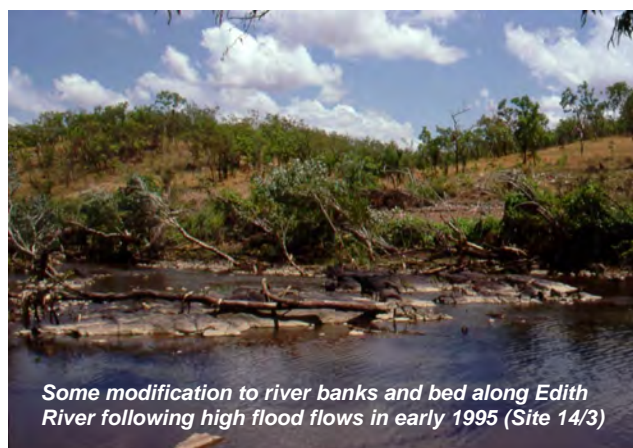
*Some modification to river banks and bed along Edith River following high flood flows in early 1995 (Site 14/3)*

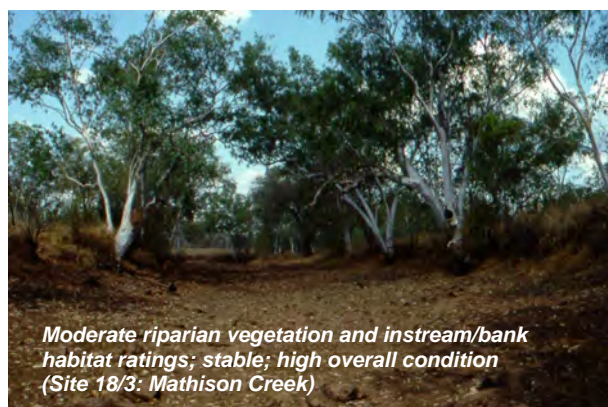
Moderate riparian vegetation and instream/bank habitat ratings; stable; high overall condition (Site 18/3: Mathison Creek)

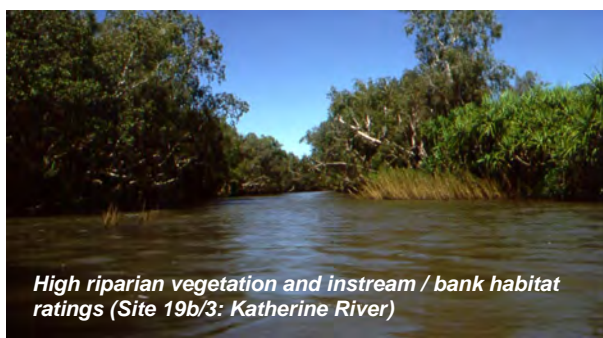
High riparian vegetation and instream / bank habitat ratings (Site 19b/3: Katherine River)

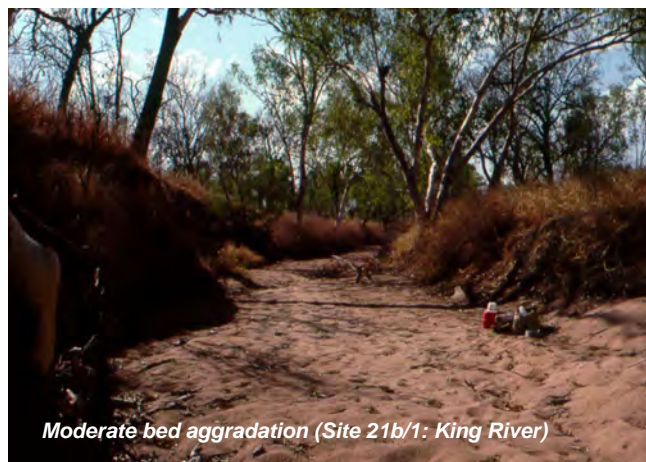
Moderate bed aggradation (Site 21b/1: King River)

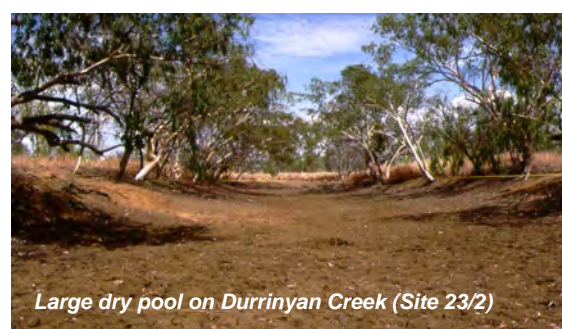
Large dry pool on Durrinyan Creek (Site 23/2)
