DALY RIVER CATCHMENT

An Assessment of the Physical and Ecological Condition of the Daly River and its Major Tributaries

Technical Report No TR99/10

July 1998

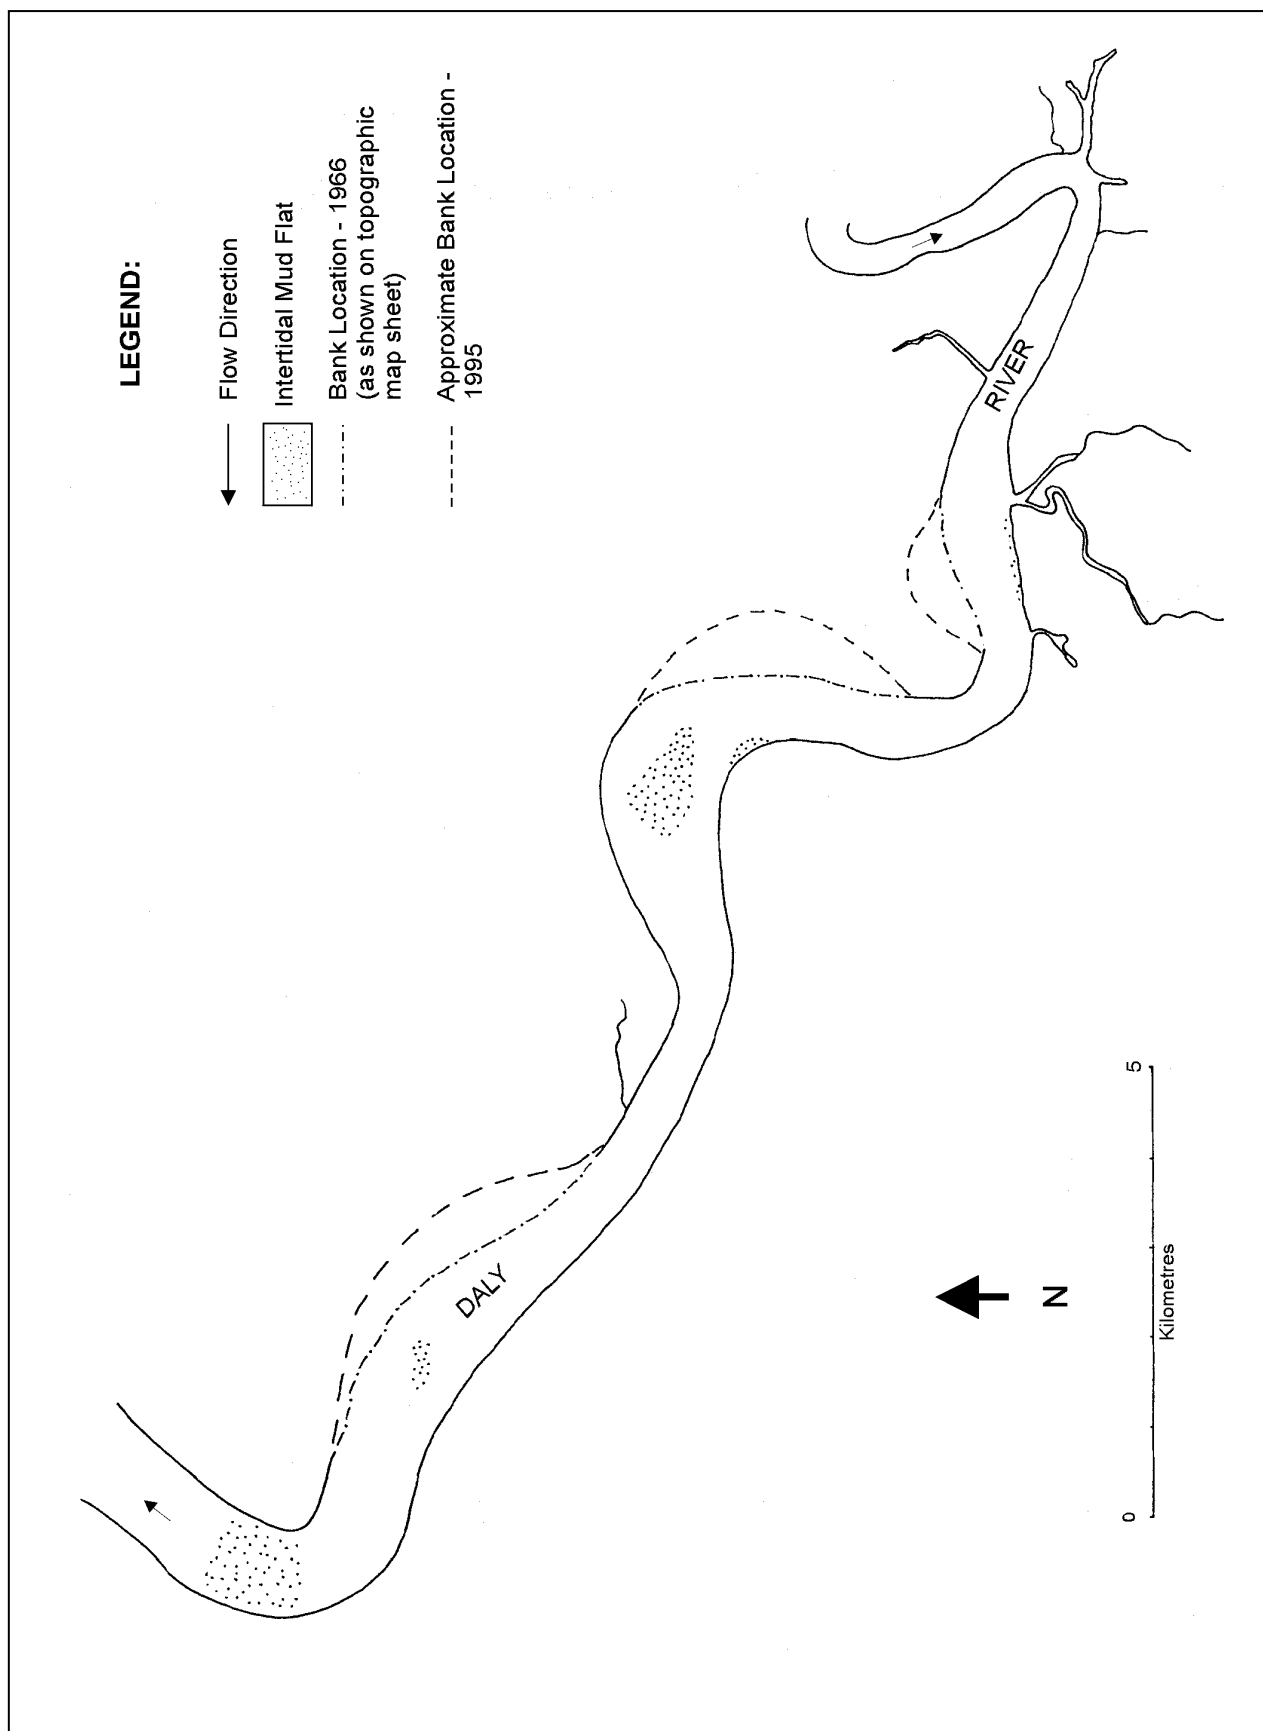
Figure 5.1 Changes in Channel Location along the Lower Tidal Section of Daly River

Downstream of site 1a/8 there were several outside bends that are migrating and the banks have eroding >1km since the topographic maps were produced in 1966. The banks along these sections are actively eroding and, as they collapse into the river, so does the riverine vegetation, which consists mostly of mangrove species. Refer Section 2.7 and Appendix A, which discusses the 'Evolution of the Daly River Estuarine Plains, noting how the river meanders along the tidal section of the Daly River are very actively migrating and the channel is "ever-changing".

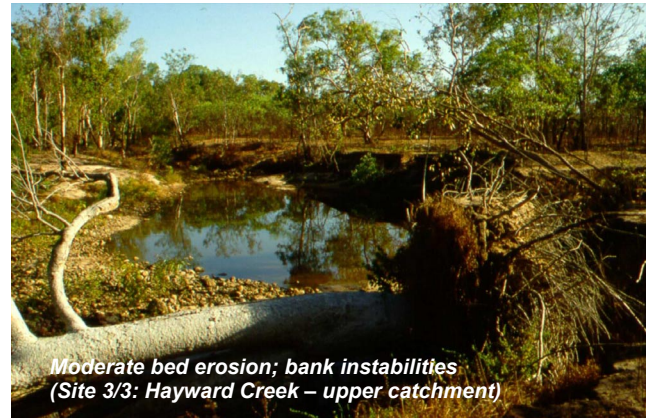
Poor creek crossing and track design and maintenance, or lack thereof, can influence the condition of creeks at a local scale, as has been shown in the upper catchment site. This emphasises the importance of properly locating creek crossings, avoiding outside bends or steep banks, and targeting areas where the creeks are shallower and have larger sediments along the bed like gravels, cobbles or boulders. As little riparian vegetation should be disturbed as possible when constructing creek crossings. Tracks should be maintained on a regular basis and should not concentrate flows along their lengths as was occurring in this upper catchment site.

Moderate bed erosion; bank instabilities
(Site 3/3: Hayward Creek – upper catchment)

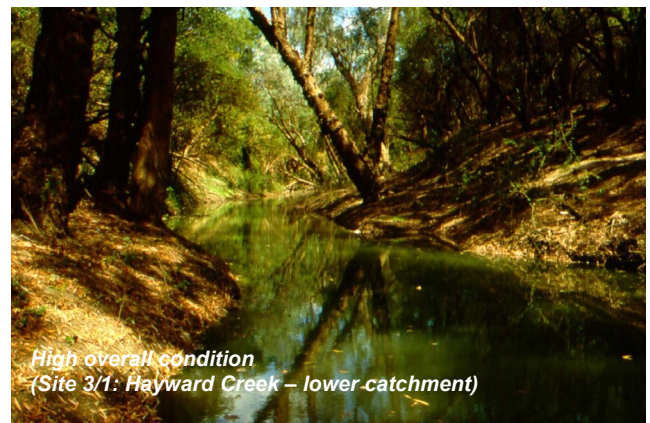
High overall condition
(Site 3/1: Hayward Creek – lower catchment)

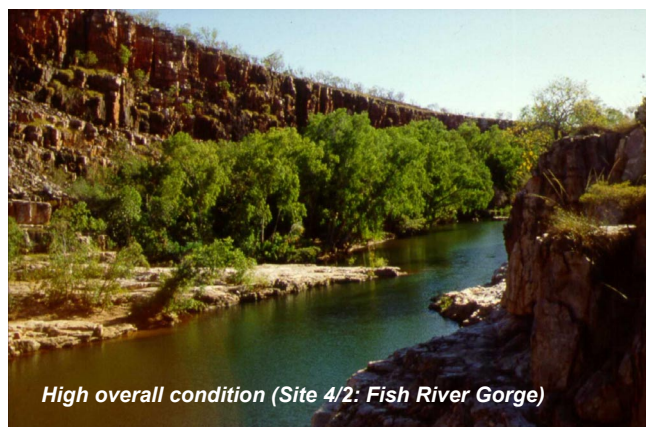
High overall condition (Site 4/2: Fish River Gorge)

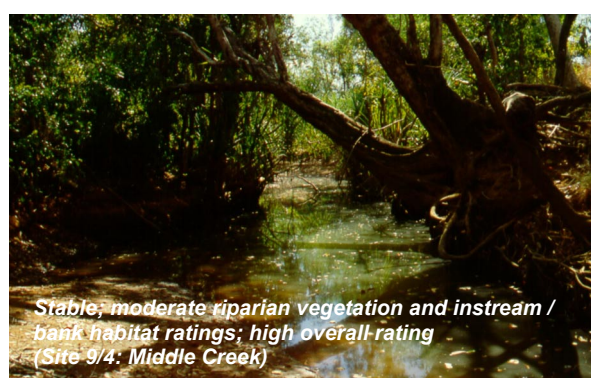
Stable; moderate riparian vegetation and instream / bank habitat ratings; high overall rating (Site 9/4: Middle Creek)

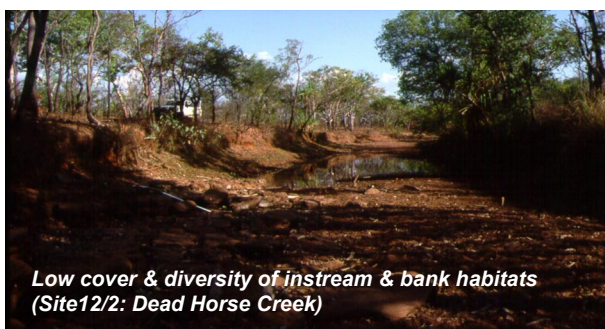
Low cover & diversity of instream & bank habitats
(Site12/2: Dead Horse Creek)

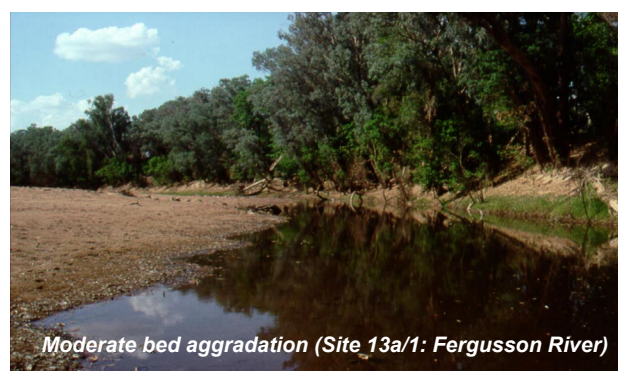
Moderate bed aggradation (Site 13a/1: Fergusson River)

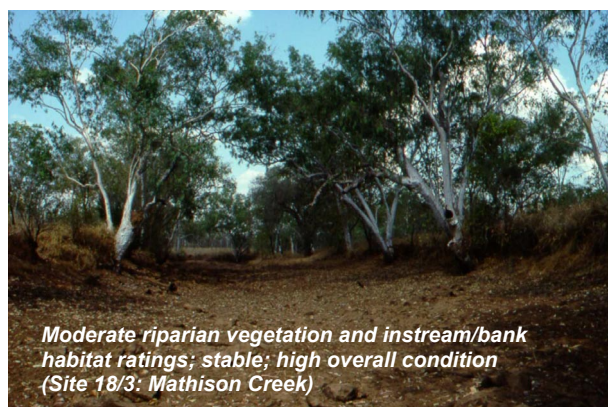
Moderate riparian vegetation and instream/bank habitat ratings; stable; high overall condition (Site 18/3: Mathison Creek)

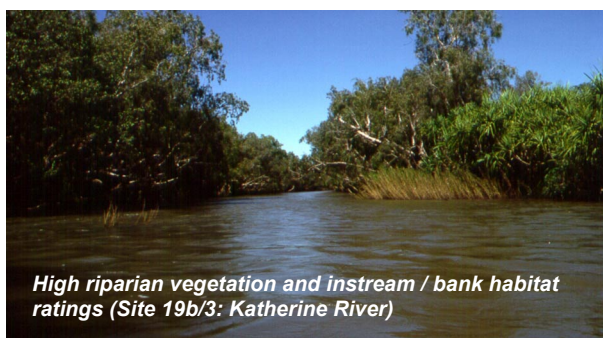
High riparian vegetation and instream / bank habitat ratings (Site 19b/3: Katherine River)

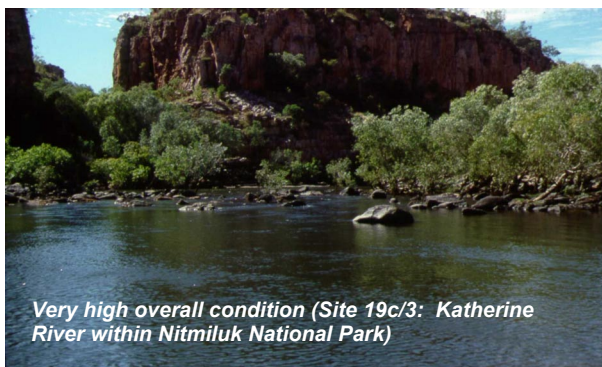
Very high overall condition (Site 19c/3: Katherine River within Nitmiluk National Park)

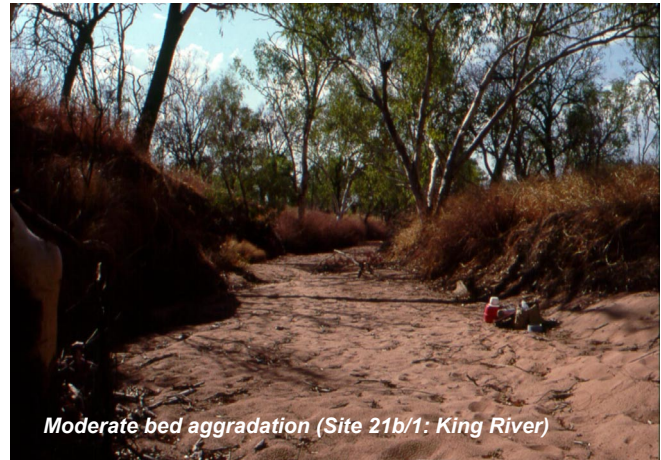
Moderate bed aggradation (Site 21b/1: King River)

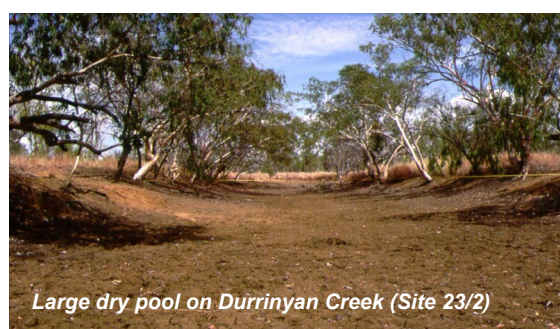
Large dry pool on Durrinyan Creek (Site 23/2)
