RE: Response to request for information (high-resolution image) received on 22 February, 2018

The Amungee NW-1H schematic cross-section attached is, as far as possible, an identical version of Figure 2 from the attachment to Origin Submission 233 - the only substantive change is to correct the fault displacement label in the legend as follows.

Amungee NW-1H schematic cross-section

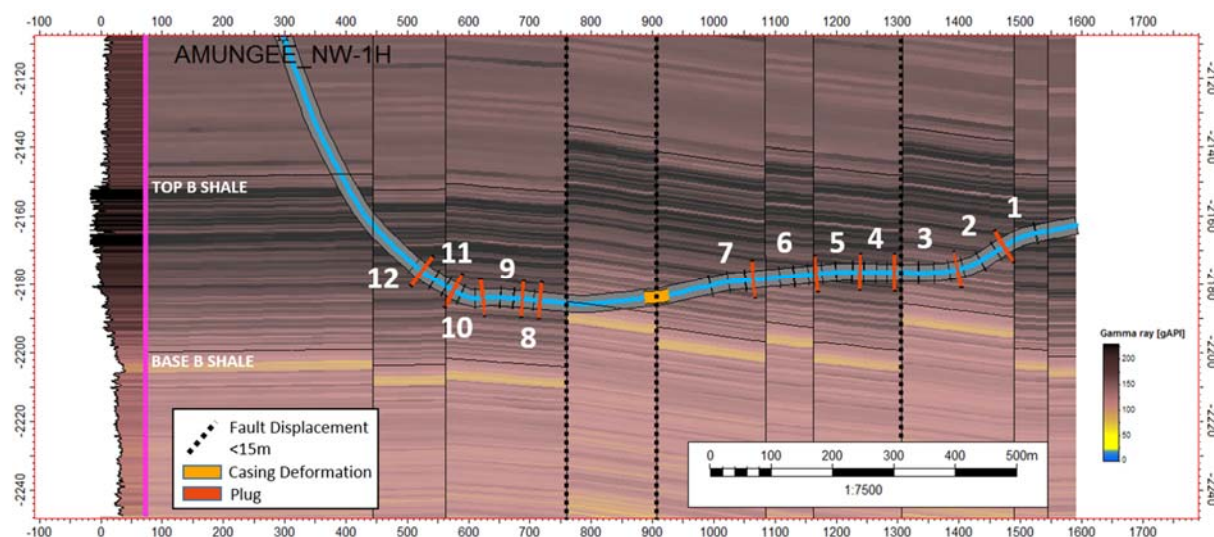
Previous: "Fault Displacement >15m"
Current: "Fault Displacement <15m"

Further details relevant to the attached figure and operations at Amungee NW-1H are included in Origin Submission 1248 (in Section 2.4).

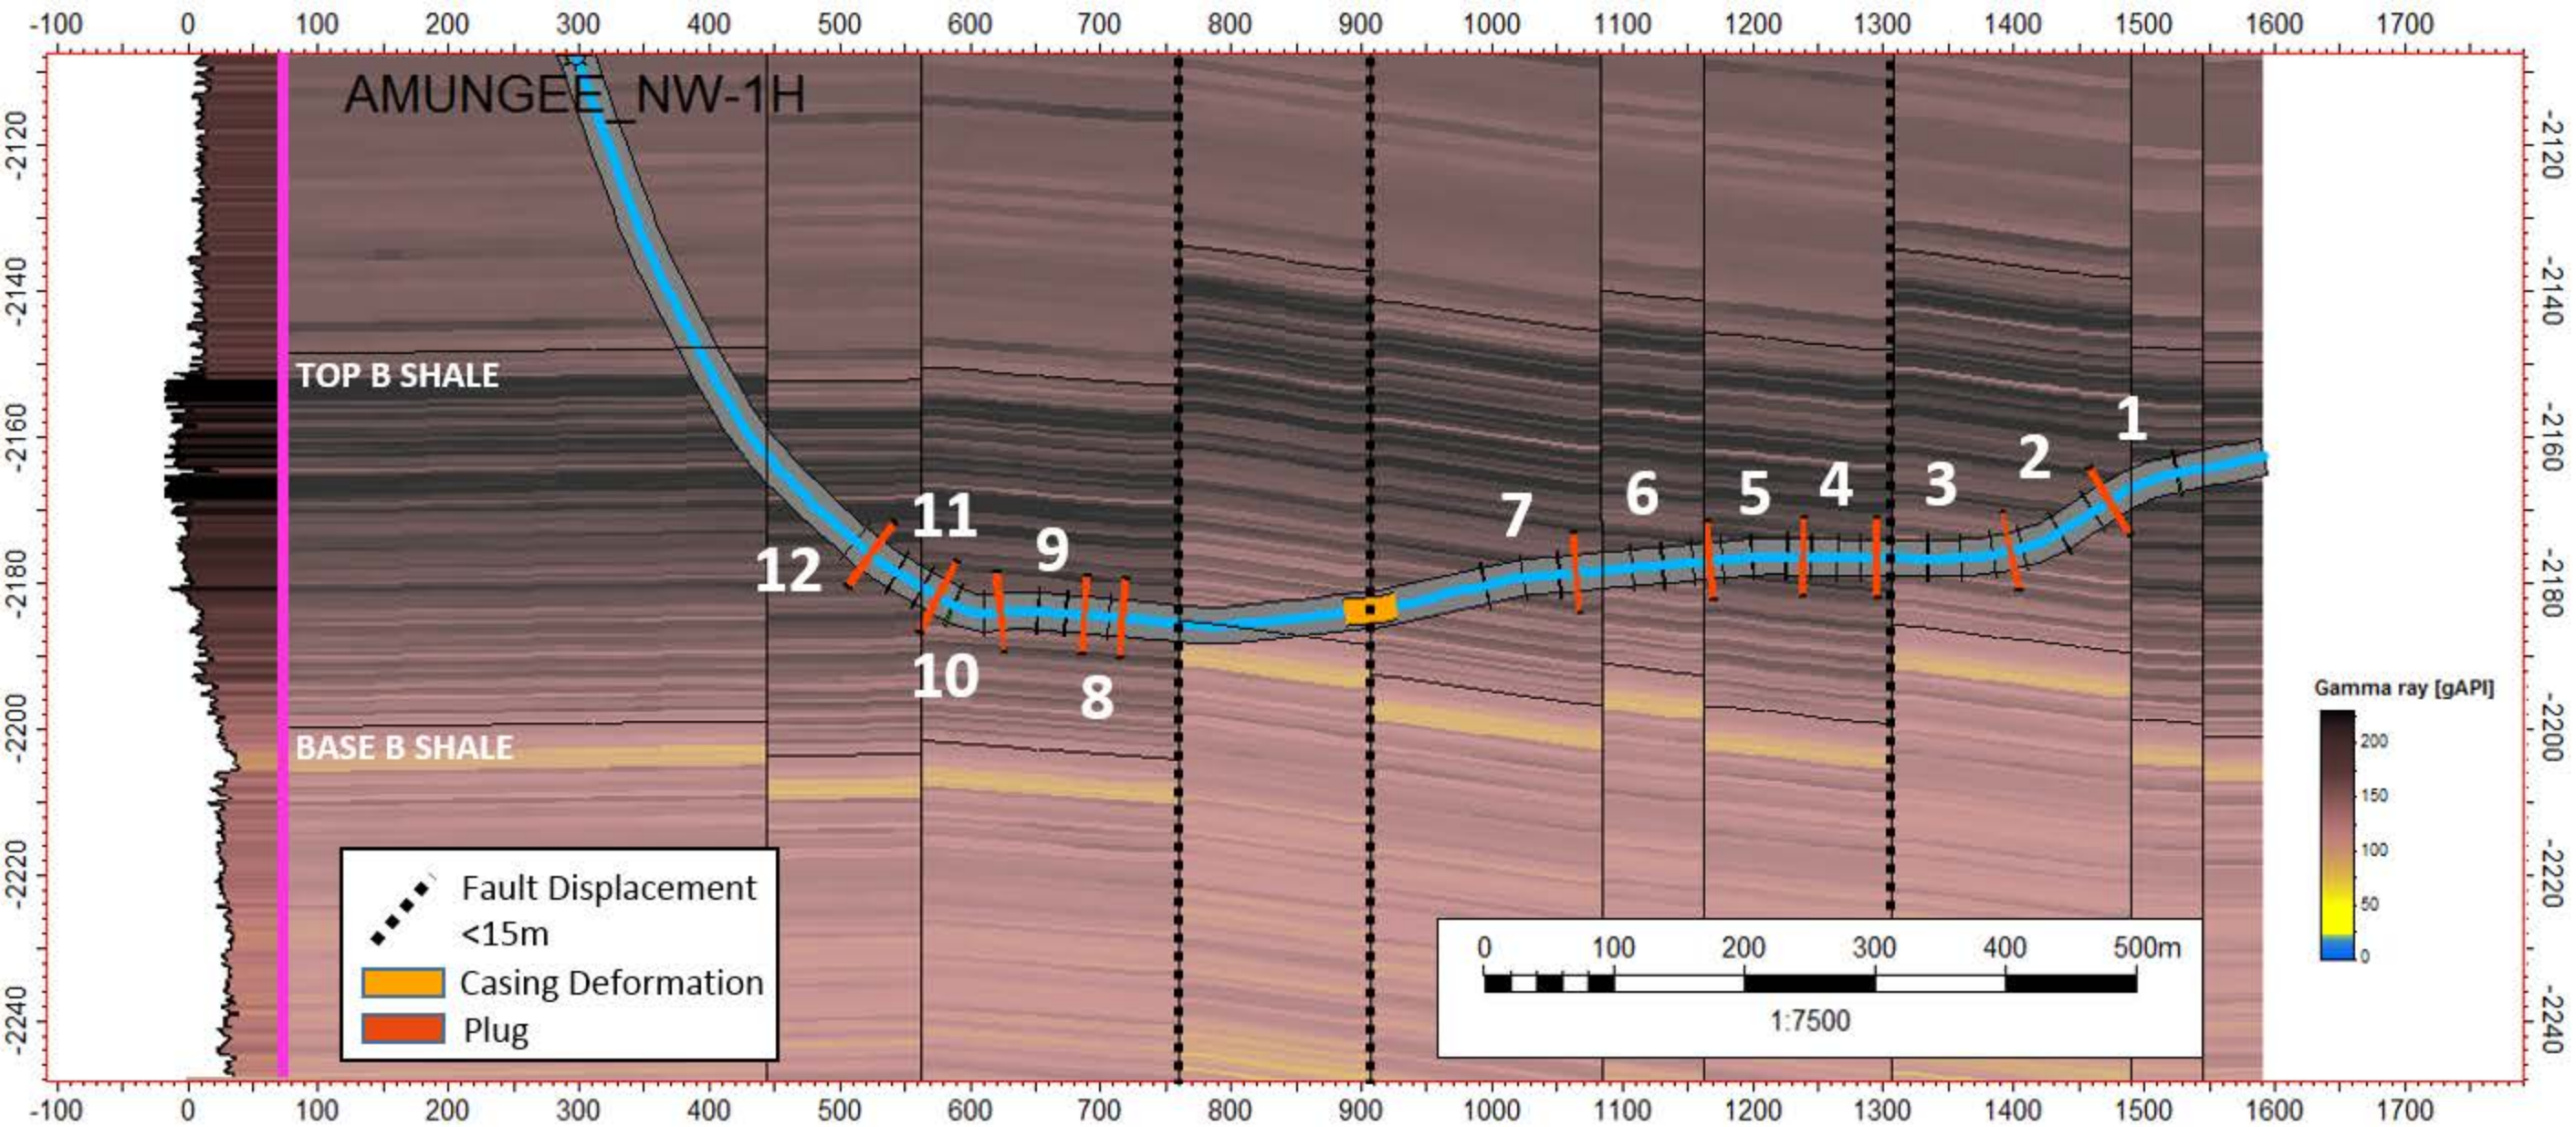
This change is necessary due to a clerical error we made with the figure in the original document attached to Submission 233. As can be seen in the figure, and was explained by Origin to the Panel on 6 February 2018 in Darwin, the correct sign is "<" as the displacement across the small discontinuities (three interpreted faults and six other discontinuities) does not exceed ~15m (the average interpreted offset of the nine faults/discontinuities is approximately 6m).

Please also note that the representation of the casing deformation in the attached image is schematic only; although it does approximately indicate location, it is not intended to represent the size of the deformation (which we interpret to be less than five to ten metres).
