VICTORIA RIVER CATCHMENT

An Assessment of the Physical and Ecological Condition of the Victoria River and its Major Tributaries

Technical Report No. 40/2004K

Conservation and Natural Resources Group
Department of Infrastructure, Planning and Environment
Katherine, NT

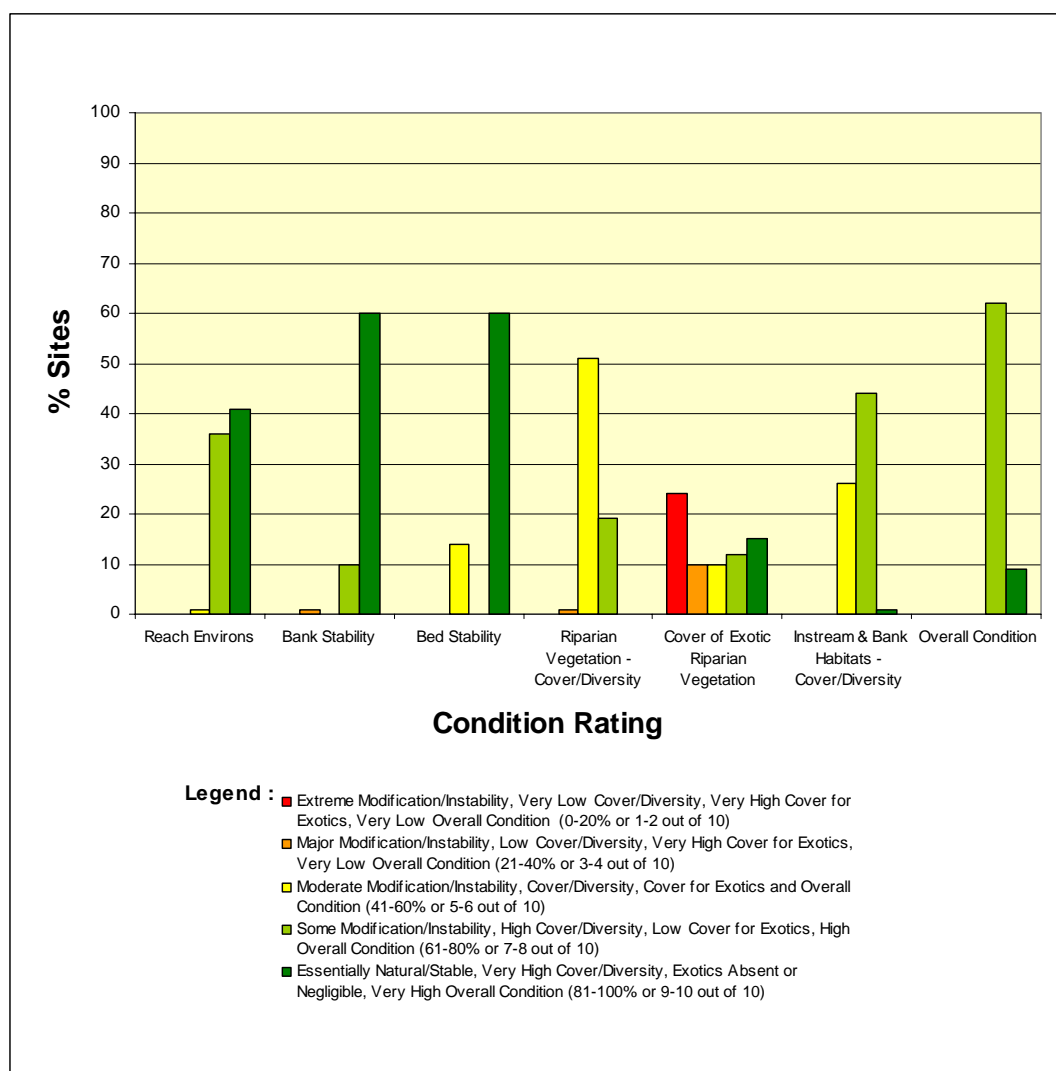
A summary of the condition and stability rating results recorded for the Victoria River Catchment are shown below:

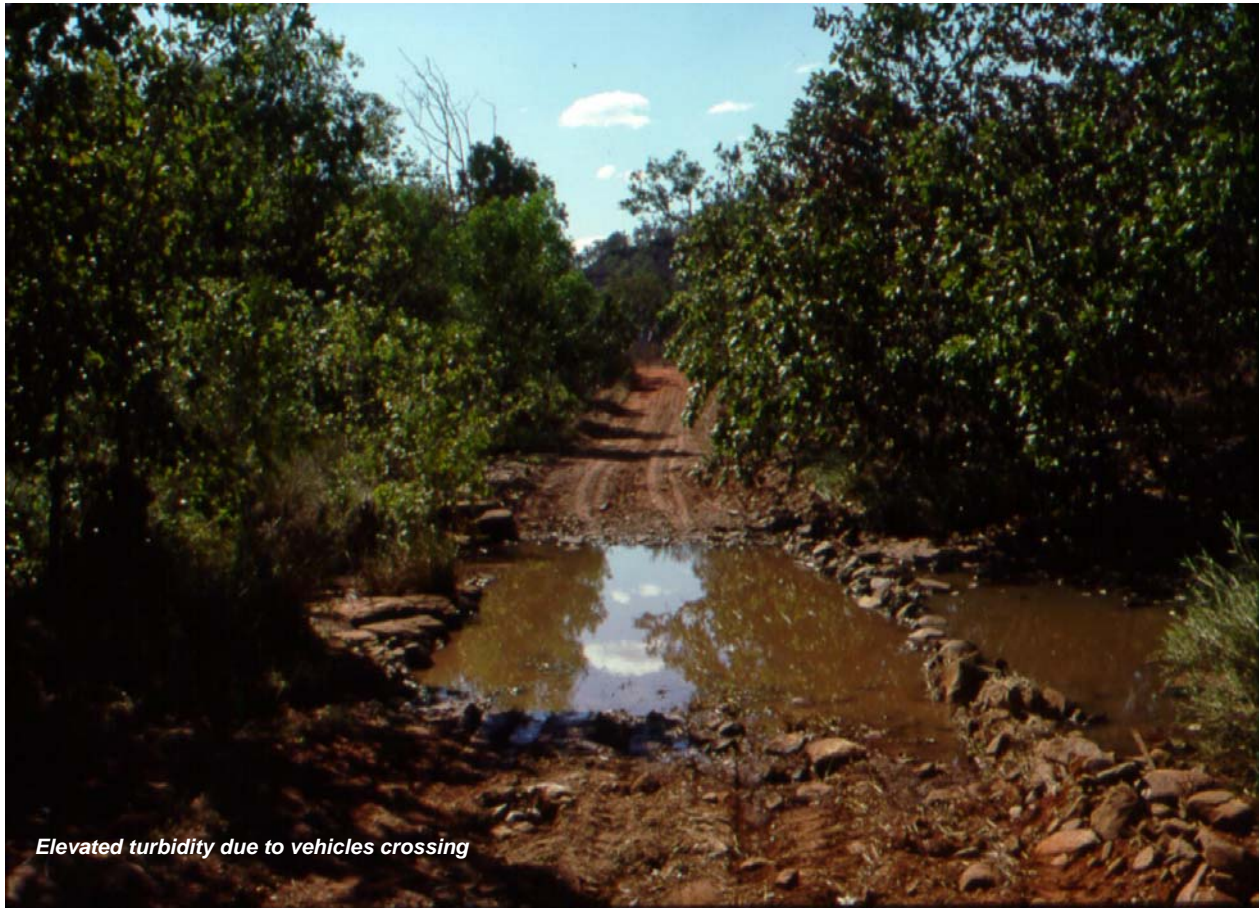
Elevated turbidity due to vehicles crossing

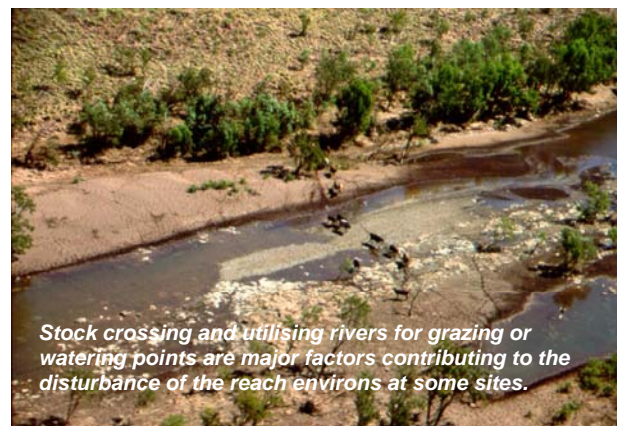
Stock crossing and utilising rivers for grazing or watering points are major factors contributing to the disturbance of the reach environs at some sites.

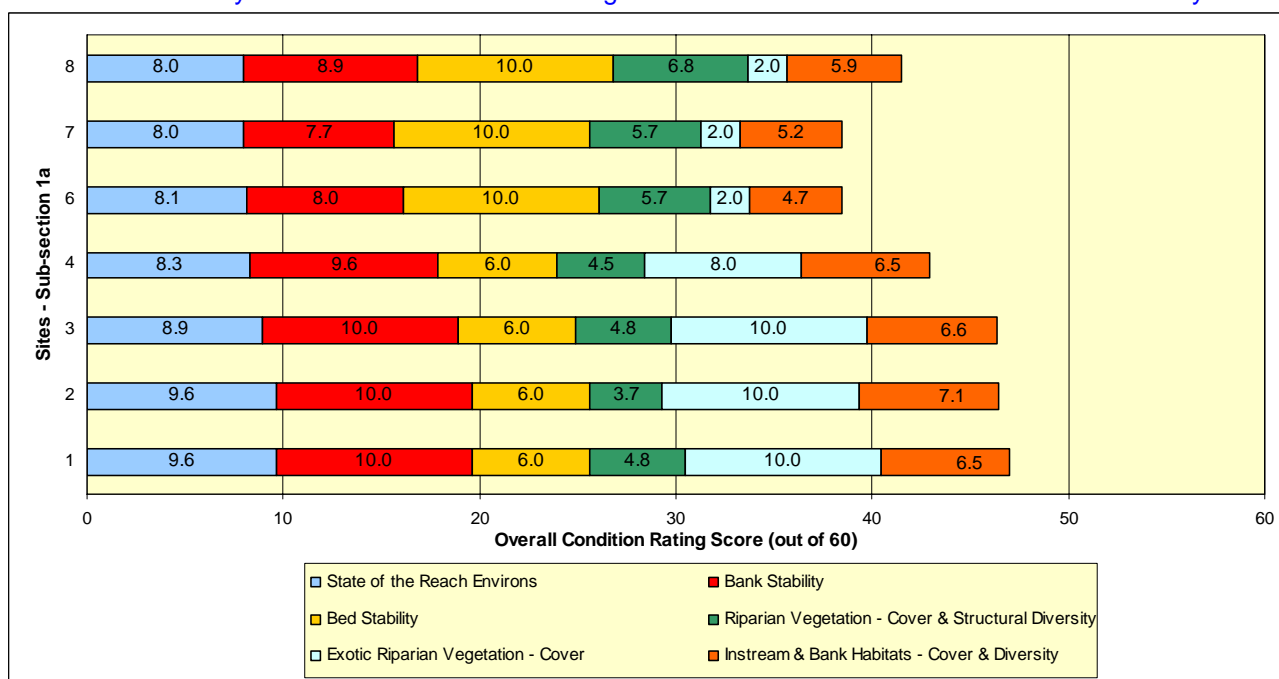
Chart 5.1 Summary of the Overall Condition Rating Score for Sub-section 1a – Victoria River Estuary

- Overall condition:** All sites were rated as having high overall condition.
- MAJOR ISSUES:** Weed invasion was high in the upper tidal reaches. Tidal influence and high flows, impacts from cattle and native fauna (eg Wallabies) were other factors contributing to disturbances. Low habitat diversity ratings can be attributed to the dominance of pools in the tidal section.

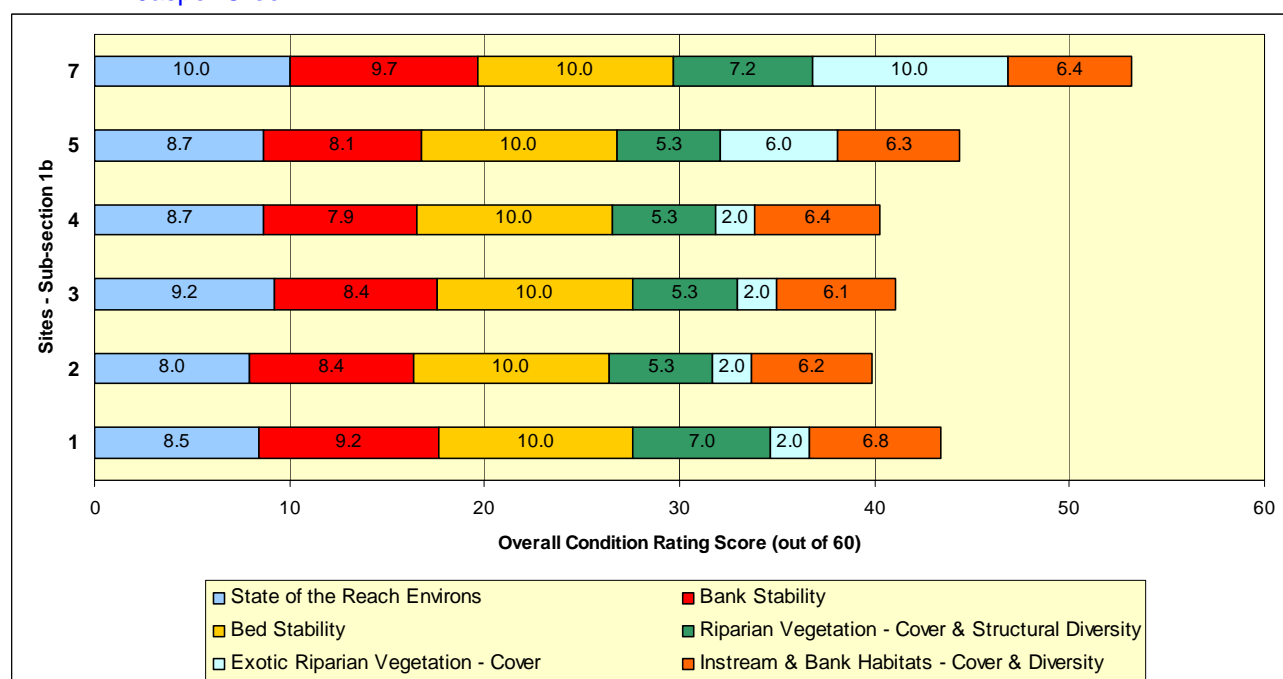
Chart 5.2 Summary of the Overall Condition Rating Score for Sub-section 1b – Victoria River below Jasper Creek

- Overall condition:** 1b_7 rated very highly overall, and the remaining sites all rated highly.
- MAJOR ISSUE:** High level of weed invasion along rivers that were located both inside and outside of Gregory National Park.

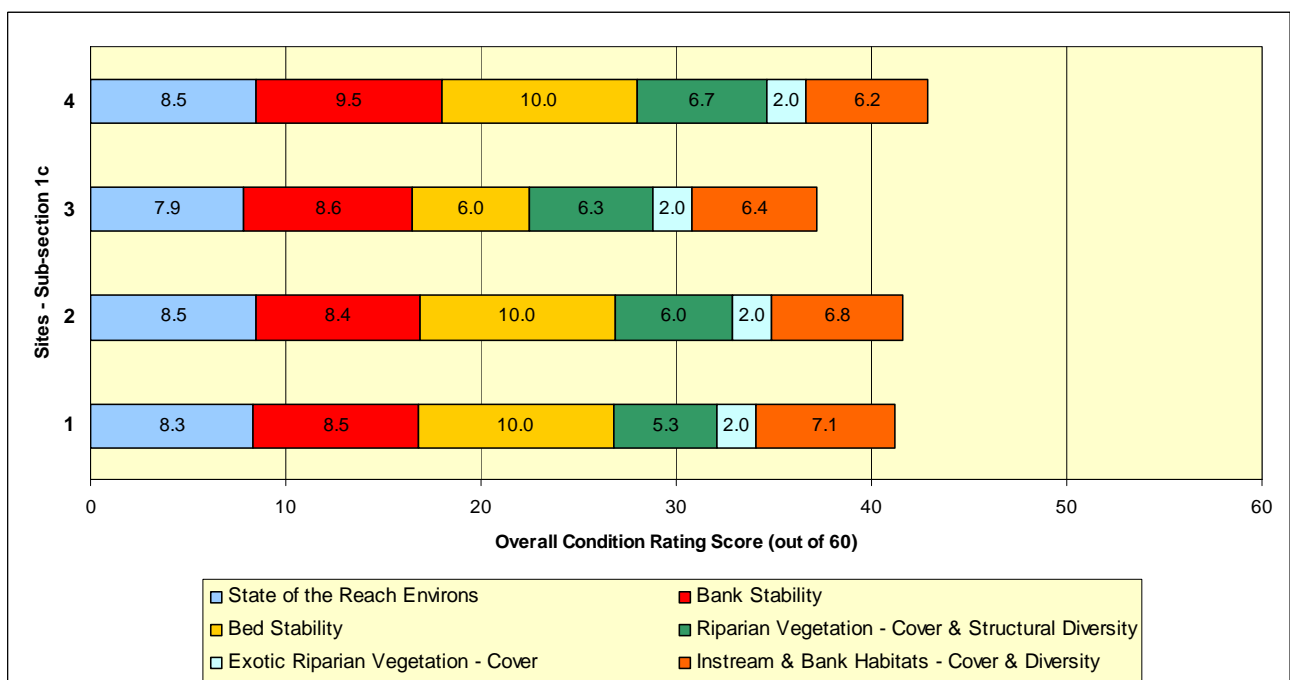
Chart 5.3 Summary of the Overall Condition Rating Score for Sub-section 1c – Victoria River – Below Camfield River

- Overall condition:** All sites rated highly overall.
- MAJOR ISSUES:** High level of weed invasion recorded at all sites, including noxious species. Some disturbance to reach environs due to stock and infrastructure like river crossings and tracks.

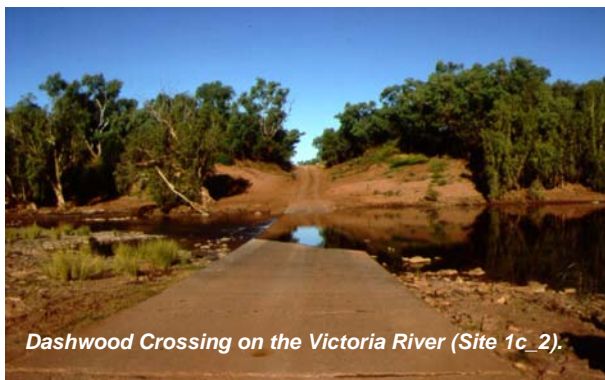
Dashwood Crossing on the Victoria River (Site 1c_2).

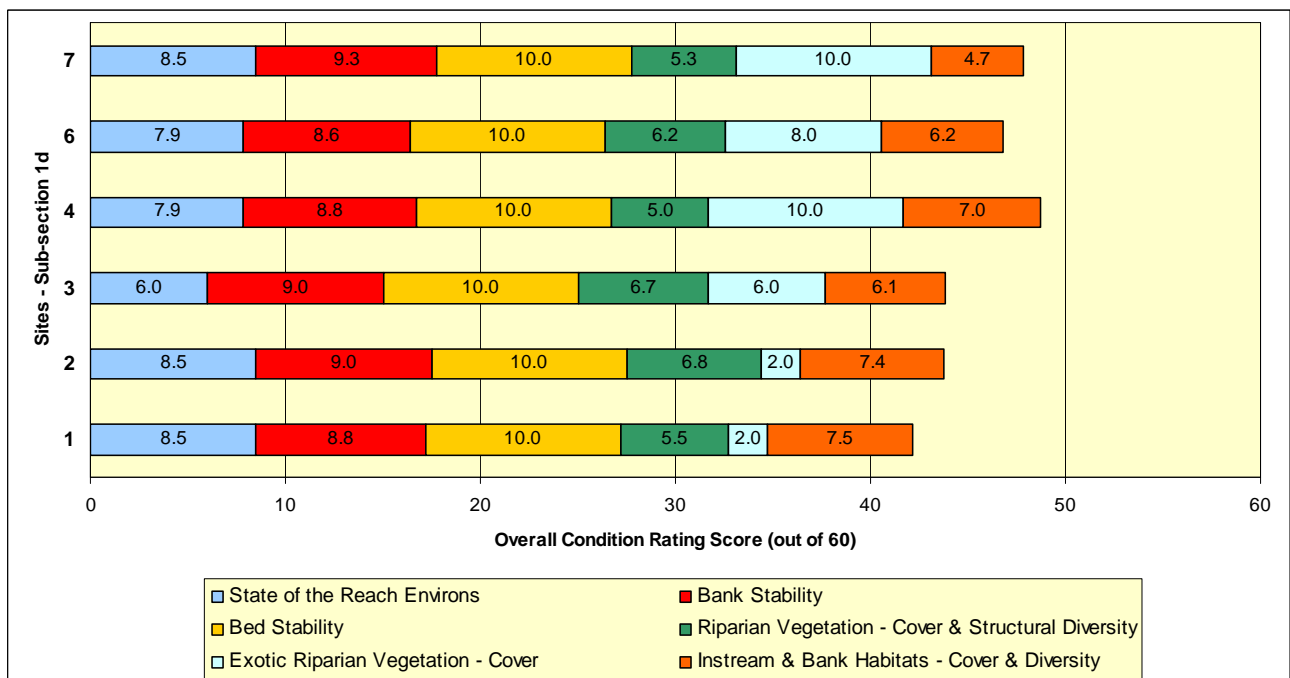
Chart 5.4 Summary of the Overall Condition Rating Score for Sub-section 1d – Victoria River – Upper Catchment

- Overall condition:** All sites were rated as having high overall condition, except 1d_4, which rated as very high.
- MAJOR ISSUES:** Disturbances to the Victoria River environment can be attributed to infrastructure and recreational activities near Kalkarindji. There is also a high level of weed invasion in the lower reaches of this sub-section of the Victoria River.

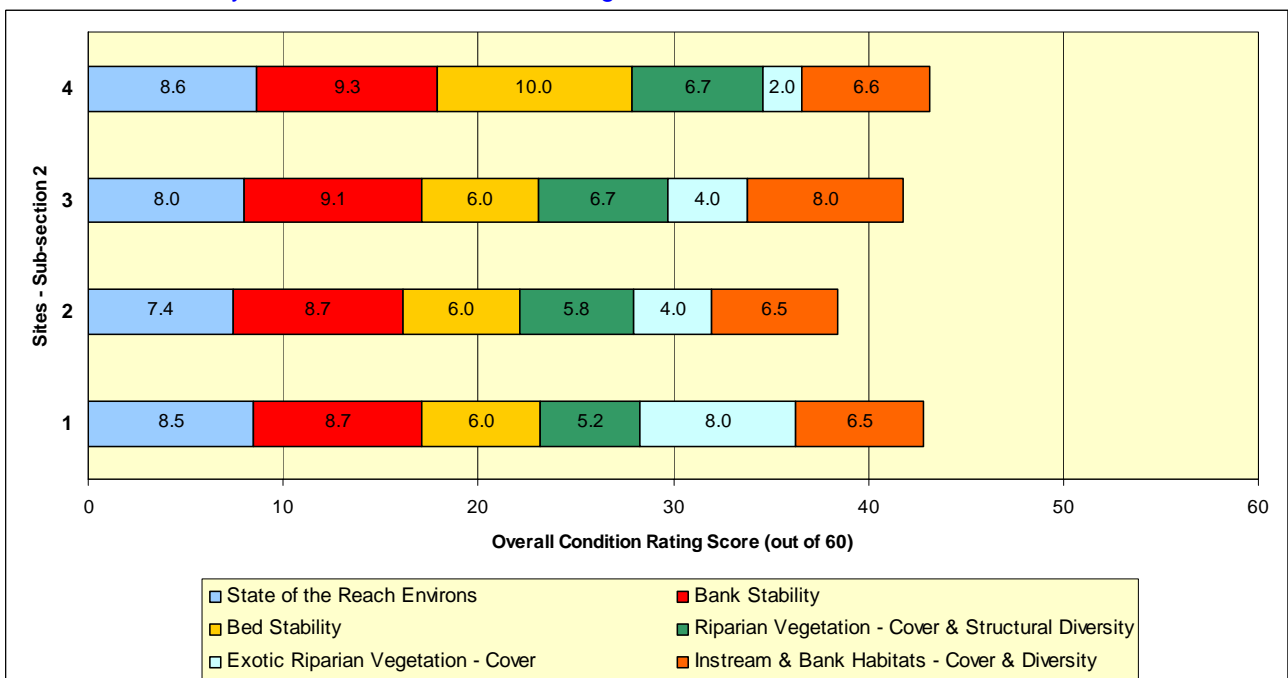
Chart 5.5 Summary of the Overall Condition Rating Score for Sub-section 2 – Bullo River

- MAJOR ISSUES:** (1) High level of weed infestation along upper Bullo River. (2) Localised degradation due to infrastructure and access to rivers by stock and feral pigs. (3) Bank slumping due to tidal influence along lower Bullo River and bed aggradation along the mid to lower sections of Bullo River.

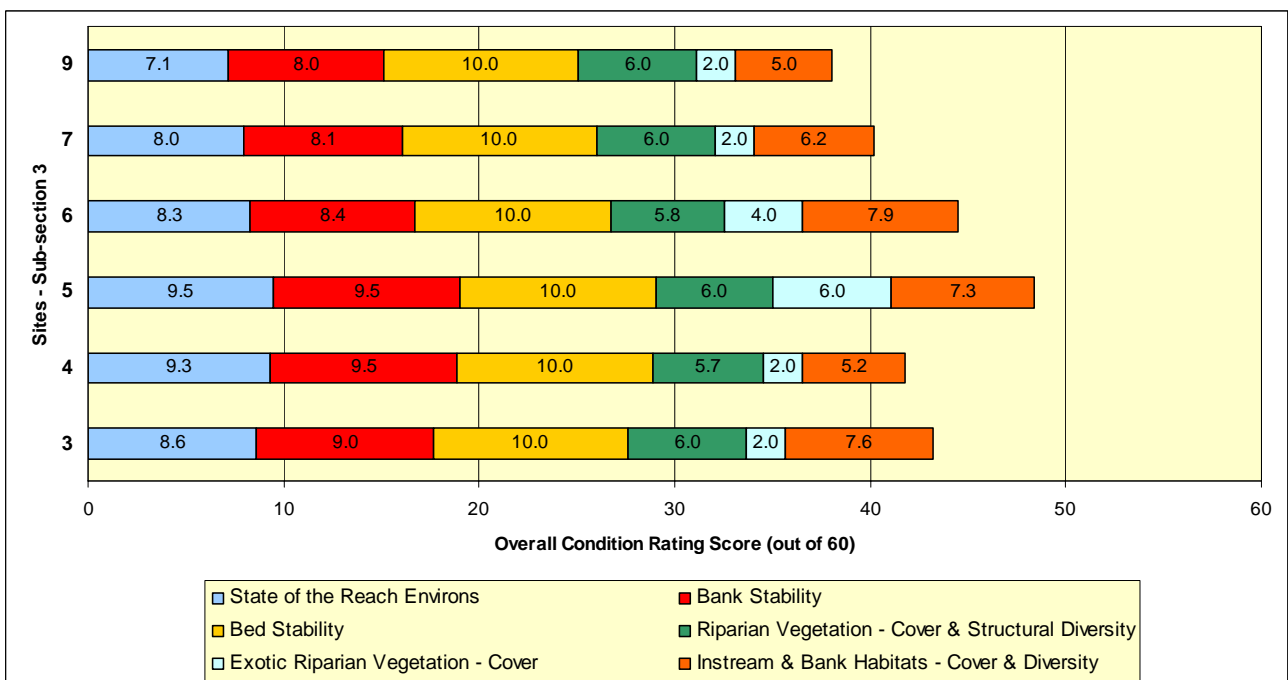
Chart 5.6 Summary of the Overall Condition Rating Score for Sub-section 3 – Baines River

- MAJOR ISSUES:** High level of weed invasion, including noxious species, at all sites. Some disturbance to reach environs and banks along West Baines River by high flows, runoff, floodplain scours, stock and vermin.

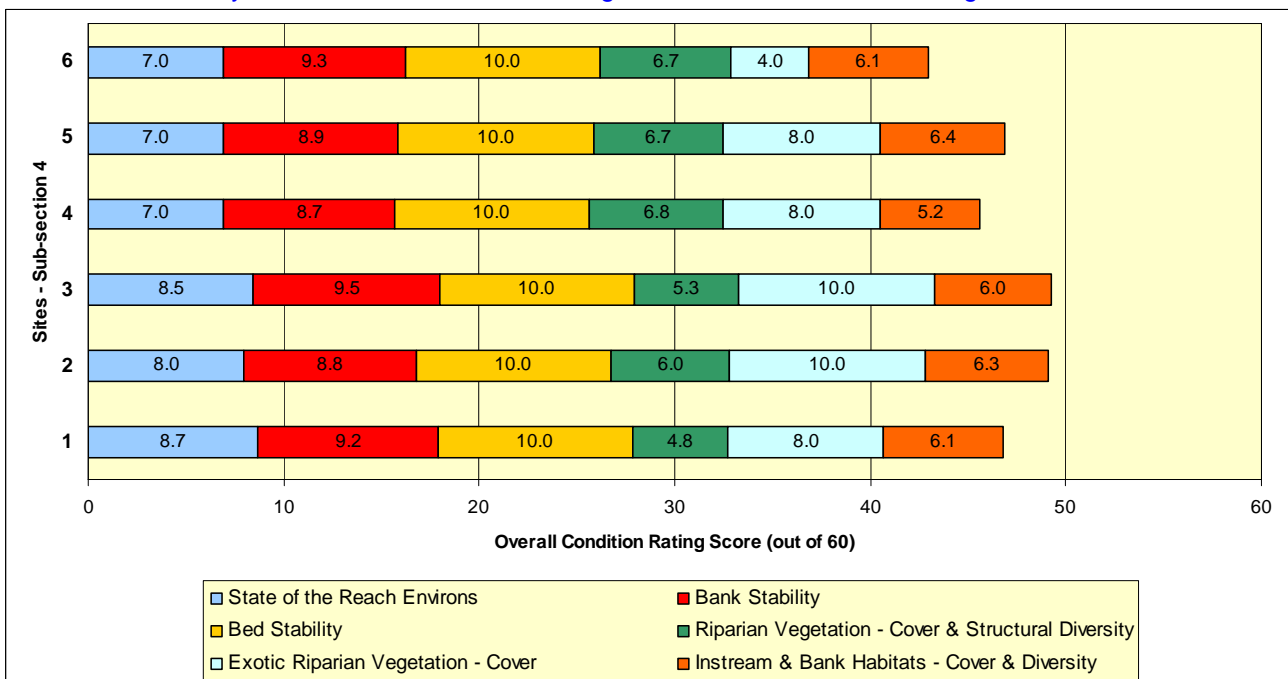
Chart 5.7 Summary of the Overall Condition Rating Score for Sub-section 4 – Angalarri River

- Overall condition:** Sites 4_2 and 4_3 rated very highly overall. The other sites all rated highly.
- MAJOR ISSUES:** Impact on river banks and reach environs by presence of stock and vermin, particularly pigs, horses and donkeys. Moderate level of weed invasion on upper Ikymbon River.

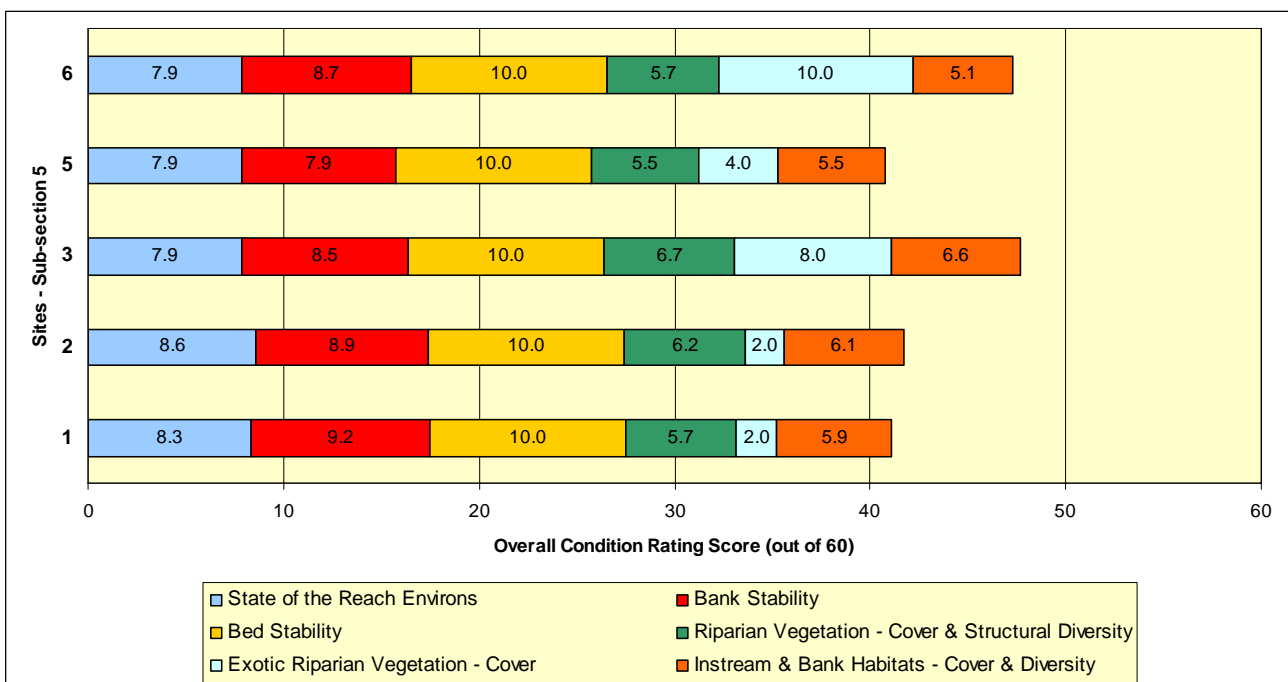
Chart 5.8 Summary of the Overall Condition Rating Score for Sub-section 5 – Gregory and Delamere Creeks

- Overall condition:** All sites were rated as having a high overall condition.
- MAJOR ISSUES:** Stock, vermin and river crossings have caused erosion within and along the upper Gregory and Delamere Creeks. High level of weed invasion at sites within Gregory National Park.

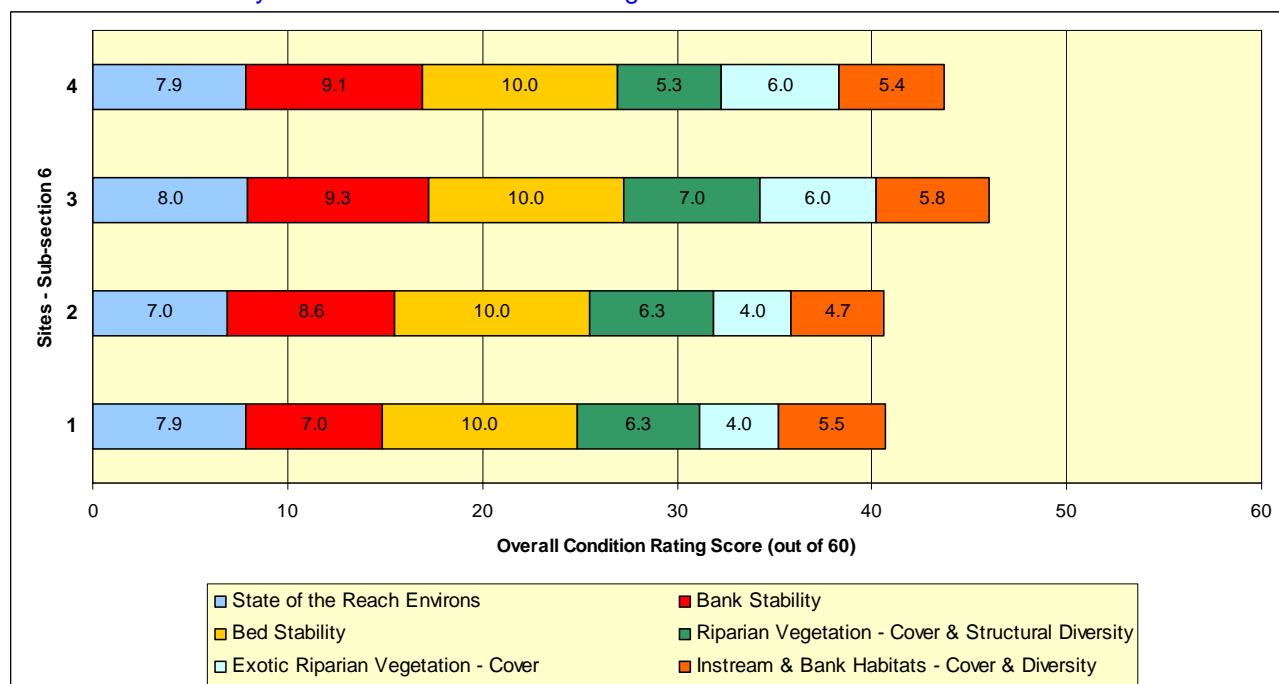
Chart 5.9 Summary of the Overall Condition Rating Score for Sub-section 6 – Battle Creek

- Overall condition:** All sites rated highly overall.
- MAJOR ISSUES:** Stock access and watering points have caused localised trampling and subsequent bank erosion. Moderate to high level of weed invasion.

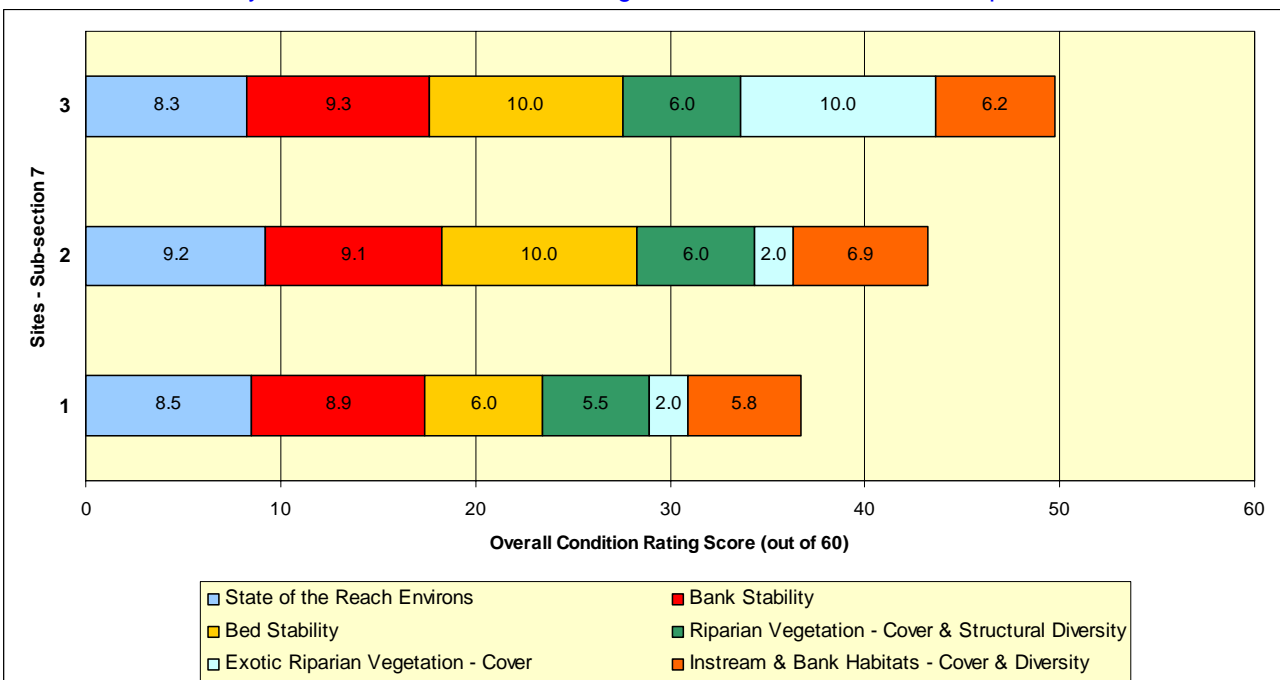
Chart 5.10 Summary of the Overall Condition Rating Score for Sub-section 7 – Jasper Creek

Exotic riparian vegetation:	No exotic species were recorded at Site 7_3, however a very high level of invasion (16-42% cover) was recorded at the two downstream sites. [Note * = species declared noxious in NT] Major species: <i>Passiflora foetida</i> Minor species: <i>Euphorbia hirta</i> , <i>Xanthium occidentale</i> * and <i>Calotropis procera</i> *
Aquatic vegetation:	Emergent aquatic vegetation was recorded at all sites assessed. Species recorded included <i>Pandanua aquaticus</i> and <i>Melaleuca leucadendra</i> .
Instream and bank habitats:	Sites were rated as having either moderate or high cover and diversity of instream and bank habitats. The canopy cover along the bank was moderate, averaging 43% of the bank length.
Overall condition:	7_1 and 7_2 rated as high, and 7_3 very highly overall.
<u>MAJOR ISSUE:</u>	High level of weed invasion in the low to mid sub-section reaches assessed on Jasper Creek.

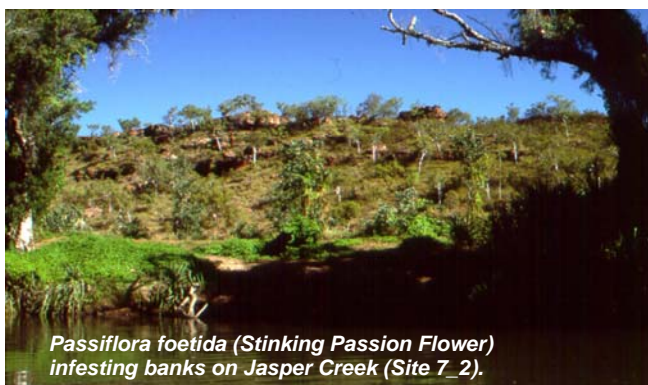
Passiflora foetida (Stinking Passion Flower) infesting banks on Jasper Creek (Site 7_2).

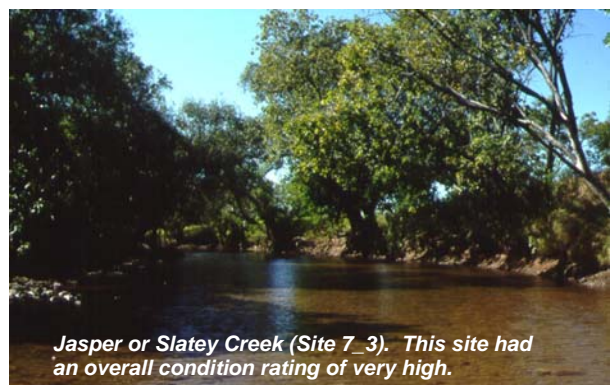
Jasper or Slatey Creek (Site 7_3). This site had an overall condition rating of very high.

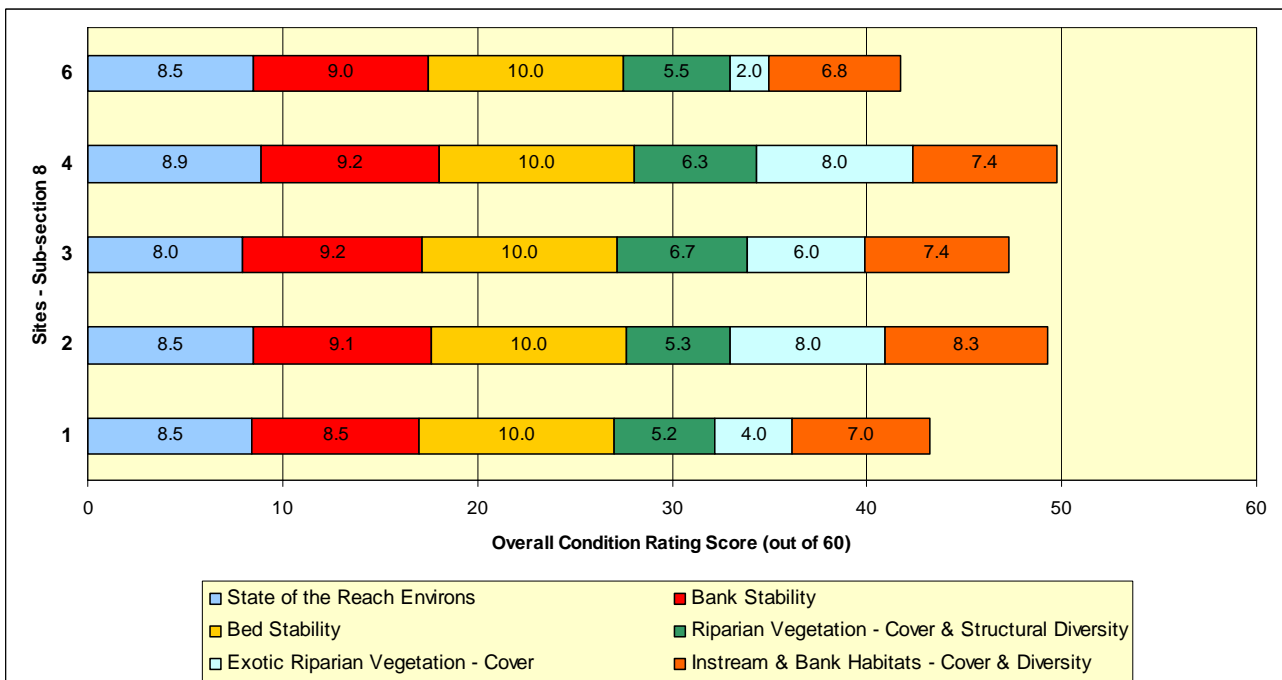
Chart 5.11 Summary of the Overall Condition Rating Score for Sub-section 8 – Wickham and Humbert Rivers

- Overall condition:** All sites rated highly except for 8_2 and 8_4, which had a very high overall condition rating.
- MAJOR ISSUES:** Widespread distribution of weeds, including four noxious species. Localised disturbances caused by the presence of feral animals like donkeys and pigs.

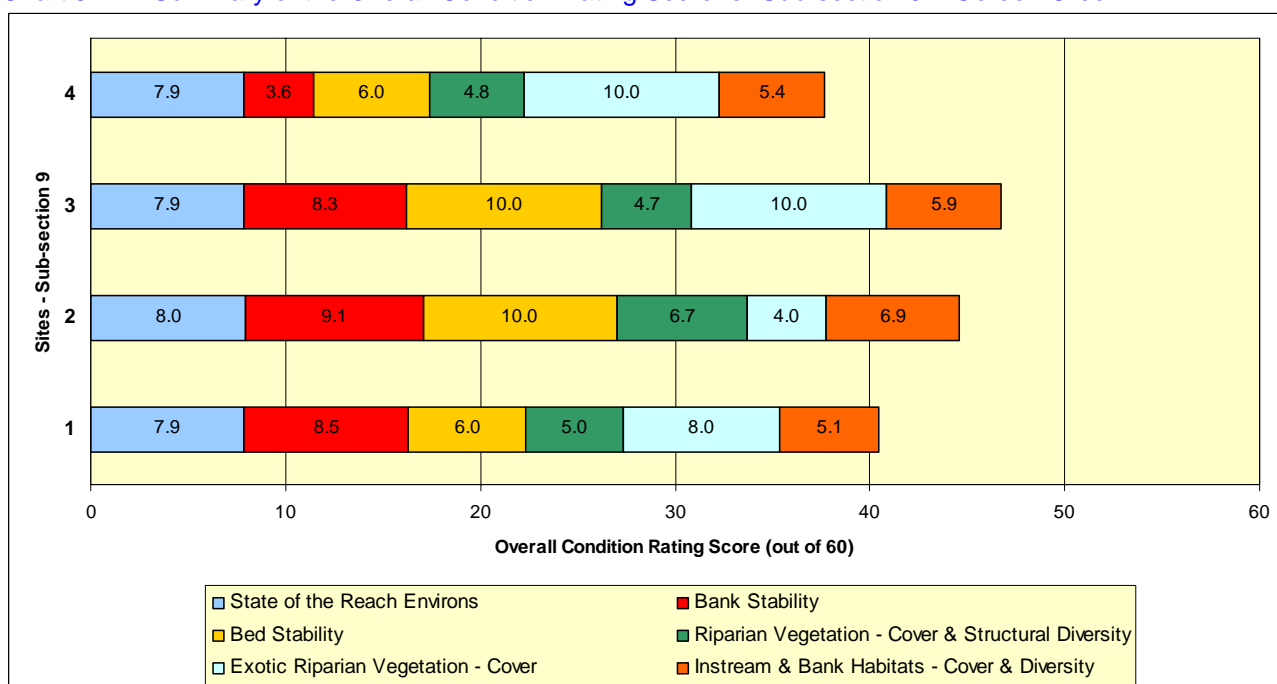
Chart 5.12 Summary of the Overall Condition Rating Score for Sub-section 9 – Gordon Creek

- Overall condition:** All sites rated highly overall.
- MAJOR ISSUES:** Impact of stock, tracks and river crossings on river banks, river beds and reach environments. Weed invasion along Gordon Creek.
