REHABILITATION OF FLOWING BORES IN THE NORTHERN  
TERRITORY PORTION OF THE GREAT ARTESIAN BASIN  
DRAFT

Northern Territory Government  
Department of Infrastructure Planning and Environment  
Natural Systems Division

Report No: 12/2004D

This report documents the rehabilitation of three uncontrolled artesian bores in the Northern Territory portion of the Great Artesian Basin.

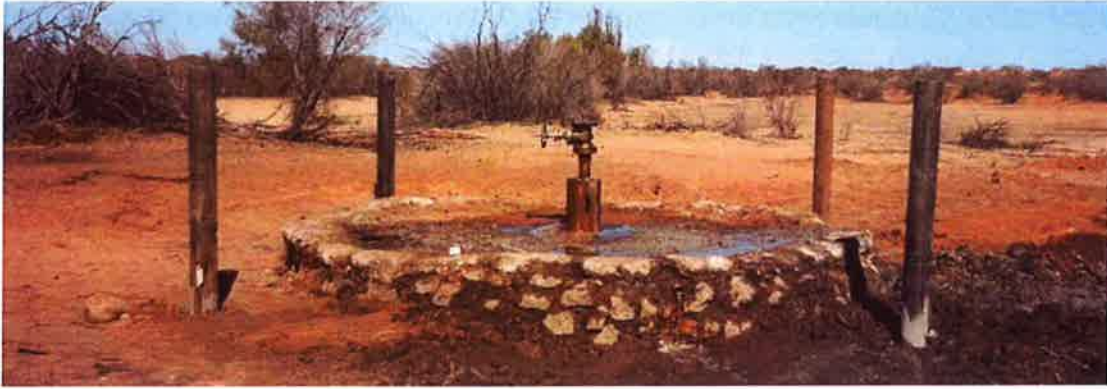
**Pic: Anacoora Bore Construction June 2000**

In order to provide headworks and some degree of rehabilitation, 90mm stainless tube was run as far as possible - to 70m. The tubing was sealed into the shale with cement. This construction is less than optimum. Nevertheless it was the best that could be done in the circumstances.

A steel railing was run around the cemented pad. A stainless steel valve was fitted at the borehead so that the supply can be closed off later (eg, for periodic connection of a pressure gauge). A stainless steel outlet pipe was run from the bore head outside the railings, and the small supply was left to flow freely to the existing water hole.

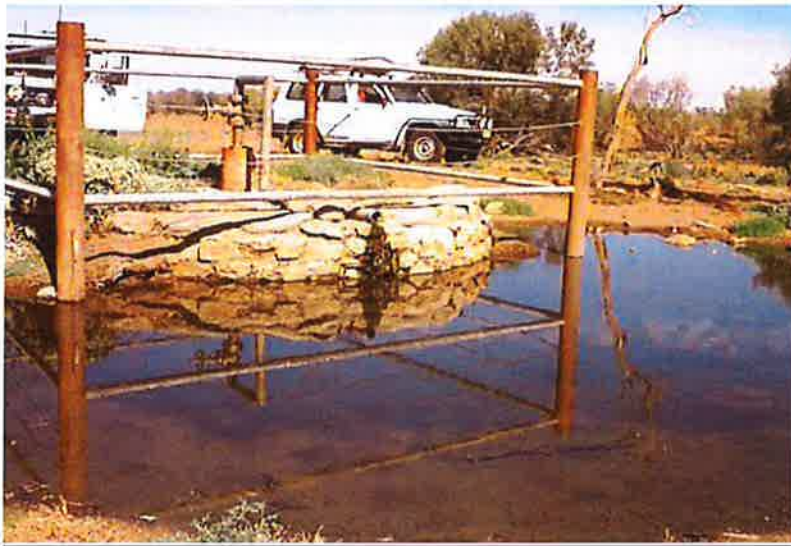
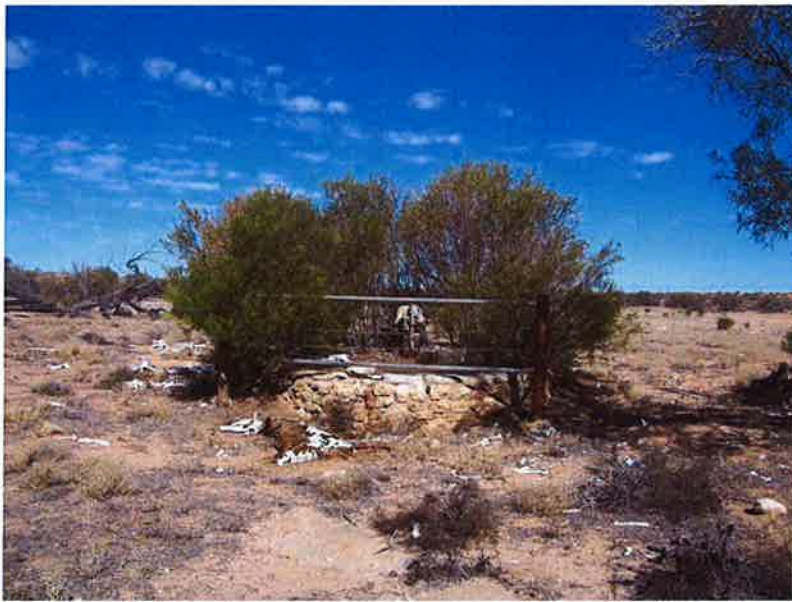
Pics: Anacoora Bore subsequently

By cementing the stainless steel casing to the surrounding shale, upward losses of GAB groundwater have been contained. Losses into the sand and limestone bands within the shale but below the cemented casing are expected to be minimal, and the rehabilitation has been successful in restricting wastage.

Headworks of Anacoora and McDills should be inspected annually, valves operated, and pressures taken as part of the regional monitoring program. Any significant changes in condition, or in aquifer pressures should trigger further assessment and appropriate action.

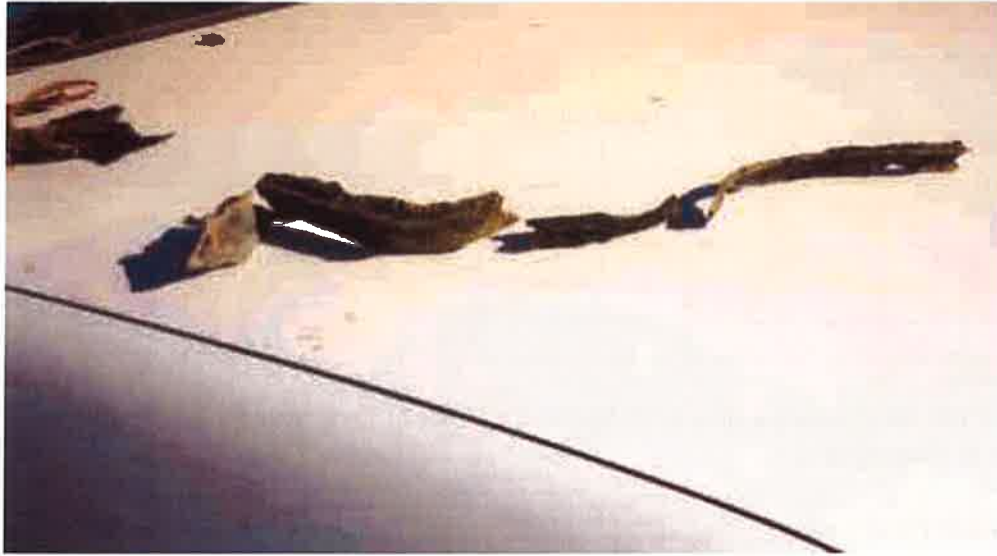
**Pic: Metal scraps recovered from Dakota Bore**

The hole was drilled out to 18m with a 5 5/8" bit; 219mm casing then ran freely to 15.4m and was driven down 17.3m where resistance increased. This was postulated to be the top of the original bore casing. An attempt was made to clean the hole out by airlifting. The airlift brought pieces of rusted casing which appeared to be approximately 150mm diameter, star picket fragments, and coarse sand to the surface.

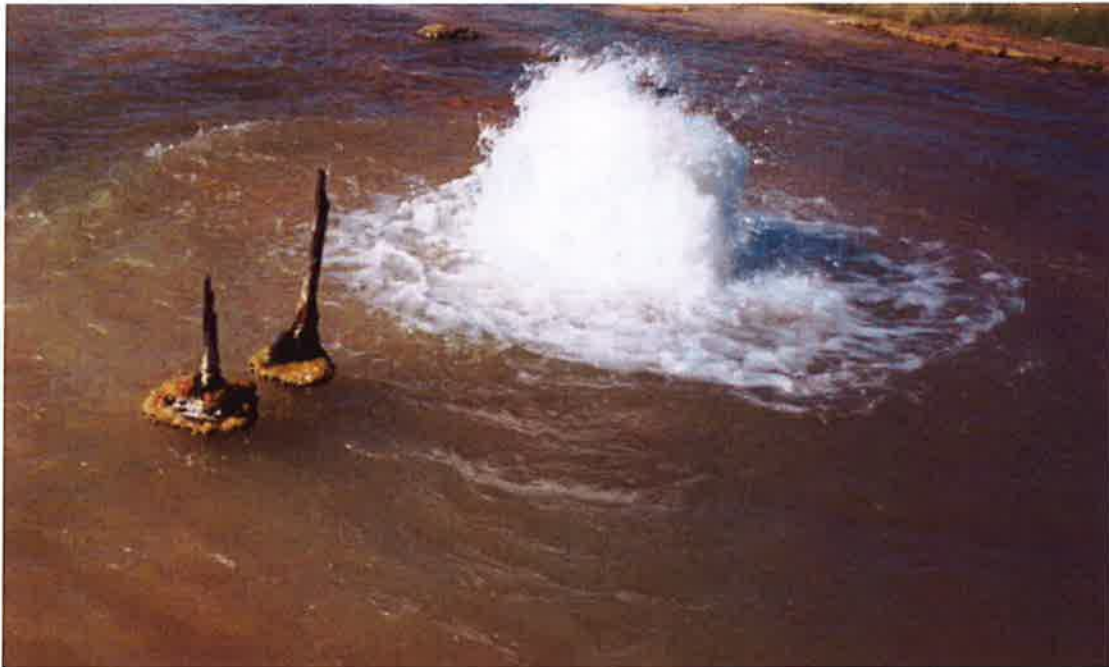
**Pic: McDills flowing uncontrolled in 1999**

Various estimates of flow were made: 100 L/s (1986), 200 L/s (1991), 50 L/s (1998) followed by an accurate measurement of 120 L/s in 2002. The traditional owner view, as reported through the Water Advisory Committee, is that this bore can be completely shut down, as the water, with 2500 mg/L TDS, is too salty for human consumption.

An artificial lake surrounding the bore had developed, with reedbeds on the banks and migratory birds often sighted on the water.

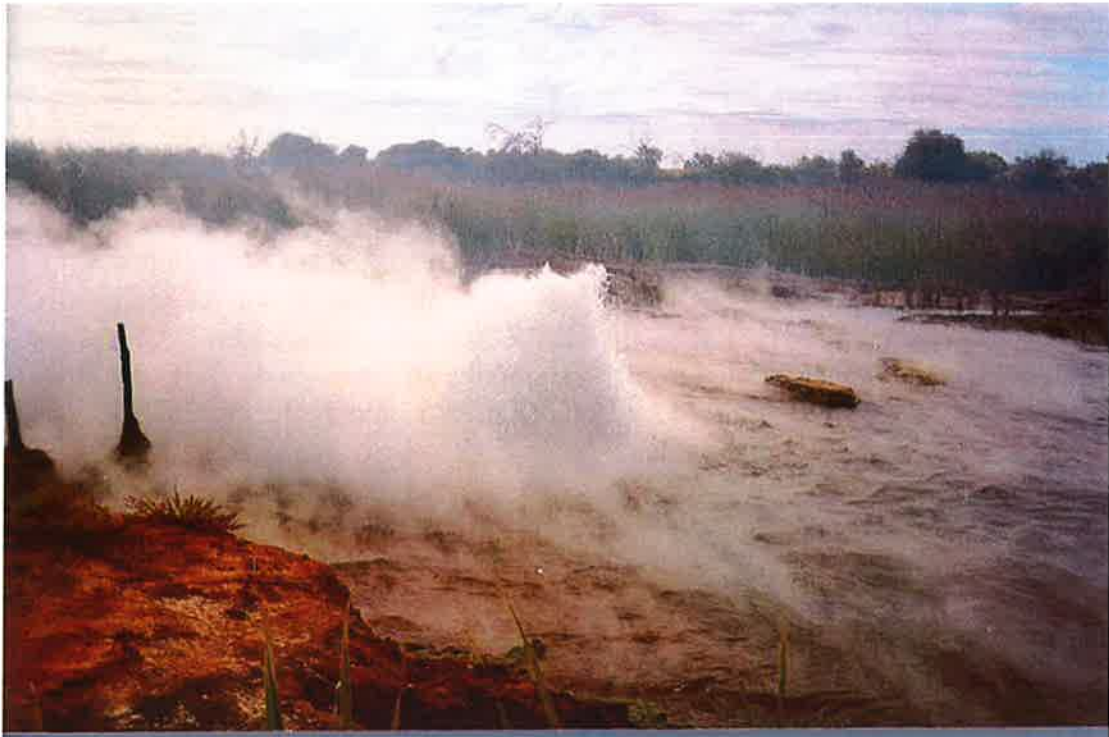
**Pic: McDills before rehabilitation – flowing approx 125 litres/sec**

Before rehabilitation the “lake” had an estimated area of 300,000 m<sup>2</sup>. Assuming an annual evapotranspiration, of say 4m (assumed higher than usual because the water was hot) gives an evaporative loss of 1200 ML/a. The flow from the bore is more than three times this rate (see section 6.3 below). Water was clearly recharging an extensive alluvial aquifer.

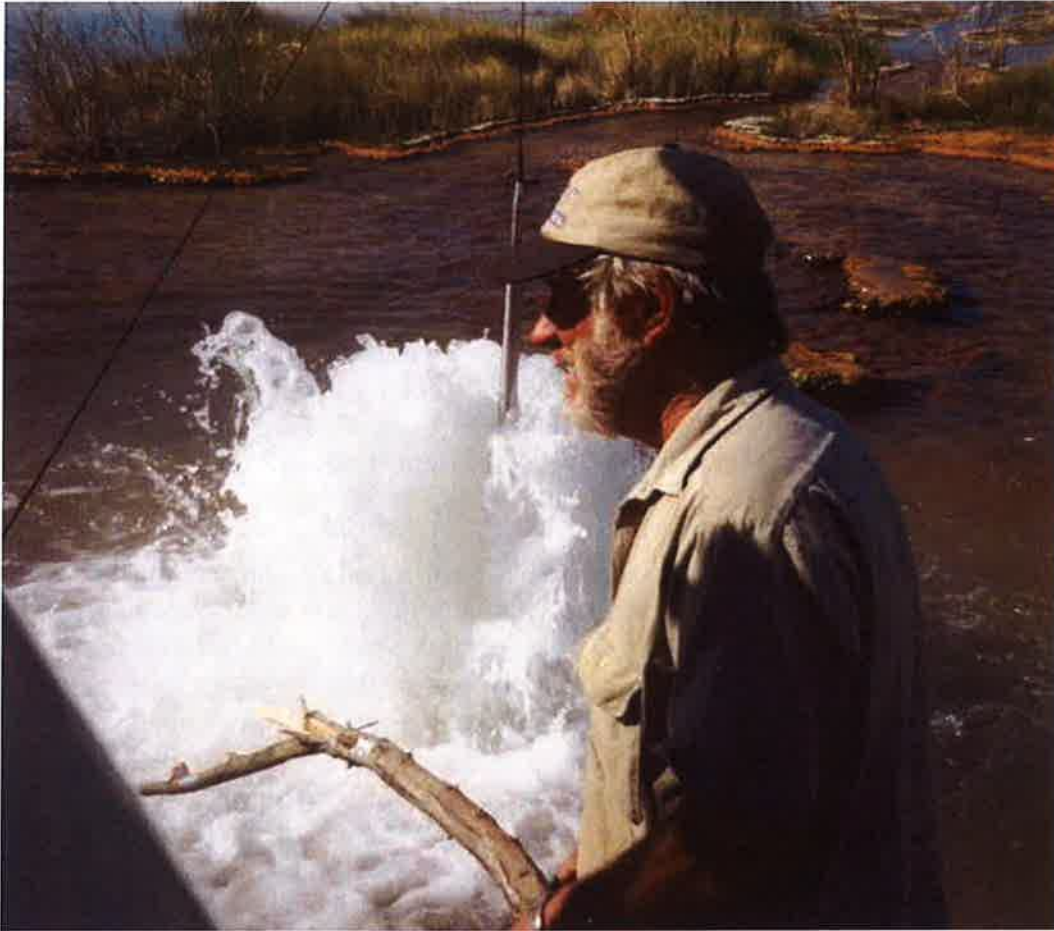
**Pic: McDills – attempting to lower logging tool into uncontrolled bore**

There was an irregular obstruction at the surface, which prevented tools from going into the hole easily. The hole was very rough internally, and 43mm-diameter tools had some difficulty in running down. Maximum depth reached by the in-hole tools was 242m; there seemed to be a firm bottom.

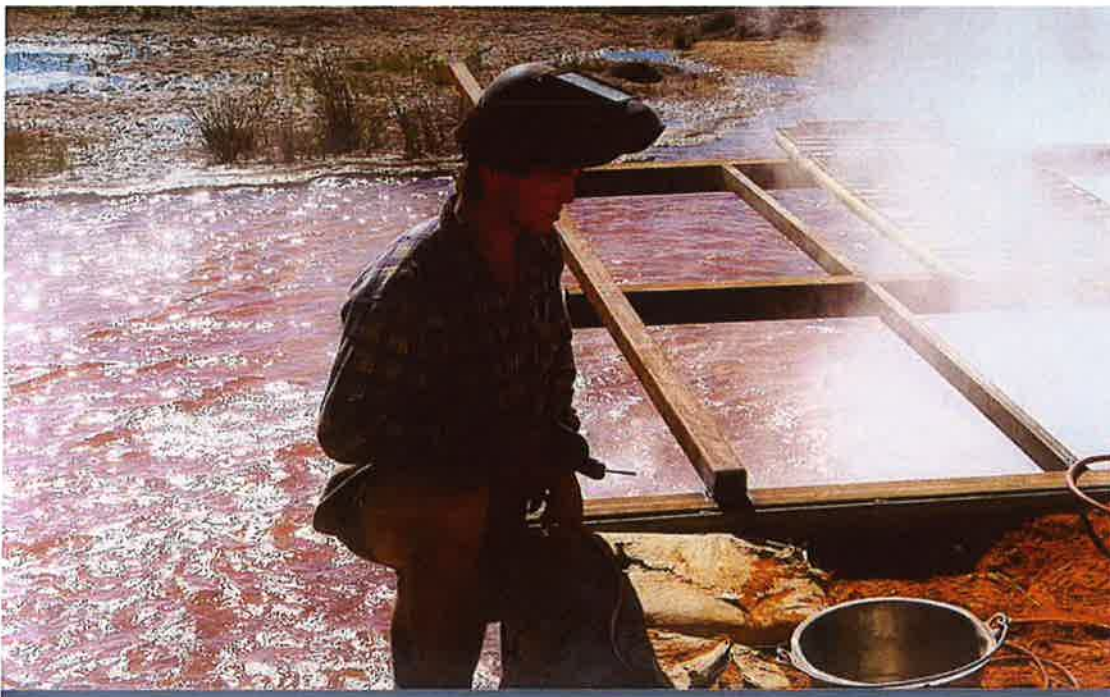
**Pic: McDills constructing platform for heavy vehicle access**

In August 2000 the ramp was upgraded and a steel platform sufficient to withstand the weight of a drill rig was constructed over the site. The earthen bank was continued to the eastern side of the dunes to prevent water flow to the southern side of the bore. As the wall was built completely across the swamp, flow to the south ceased. The southern areas was dry when next visited in. All water then flowed to the north; in April 2002 the northern swamp had extended an estimated 700m. The extra area was completely colonised by Typha species reeds.

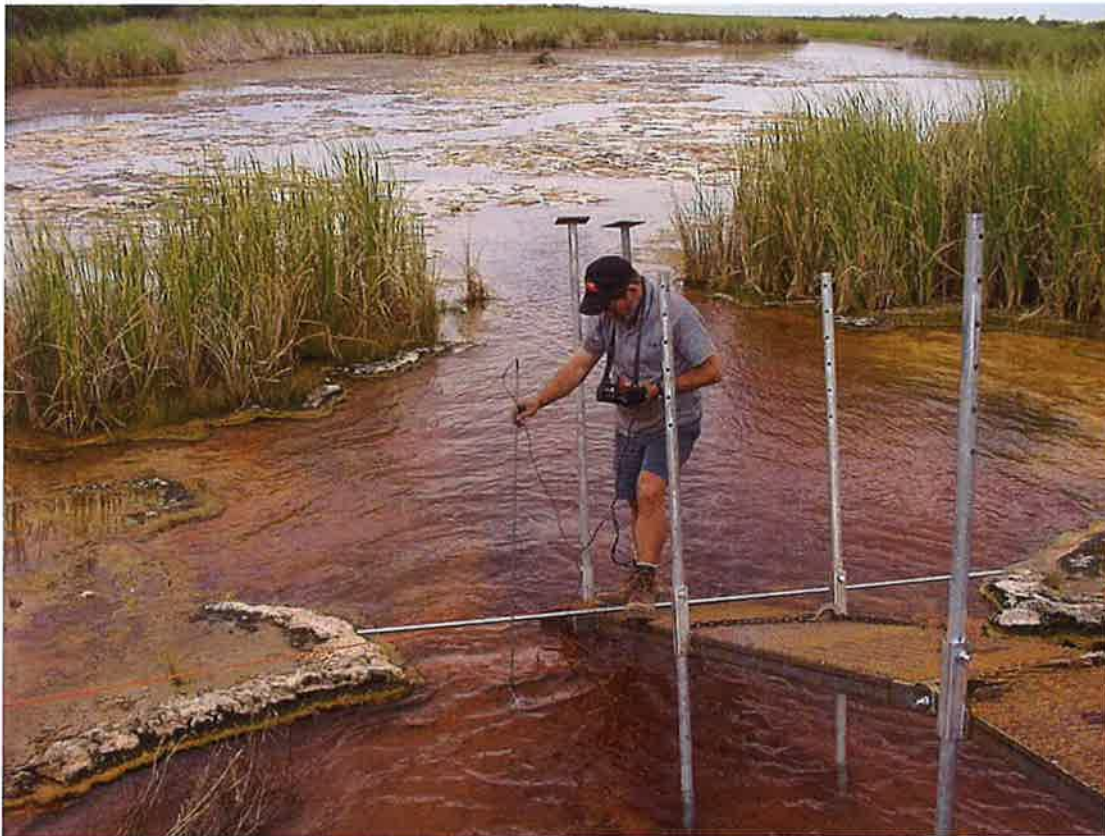
**Pic: McDills – Flow gauging after platform constructed**

In 2002 a hydrographic crew accurately measured the outflow where it was confined to a single channel within 10m of the bore. The average flow was 120 L/s, that is 10 ML/day or 3,800 ML/annum.

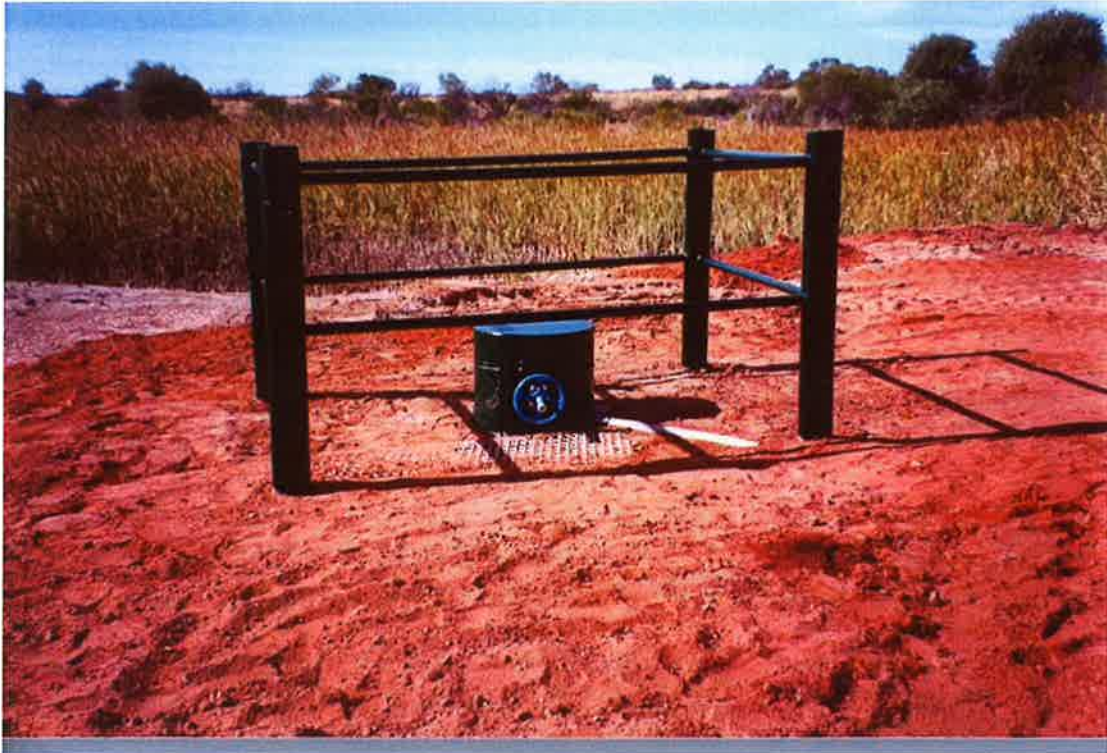
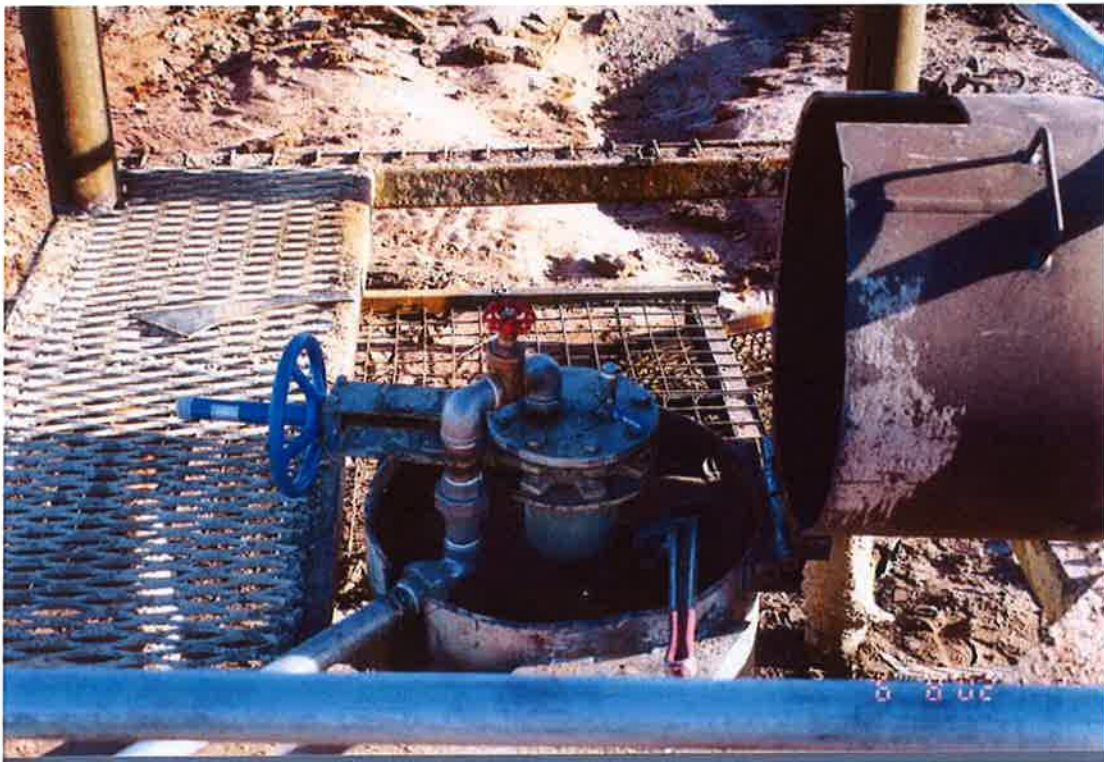
**Pic: McDills headworks after rehabilitation**

Headworks consist of a 5" full-flow stainless steel knife valve with a locked, heavy steel protection cap. A 25 mm orifice in the top flange provides a primary flow restriction, further controlled with a 40 mm gate valve before flowing 130 m through 40 mm stainless steel pipe to establish a small wetland area.
