# DALY RIVER CATCHMENT

### An Assessment of the Physical and Ecological Condition of the Daly River and its Major Tributaries

Technical Report No TR99/10

**July 1998**

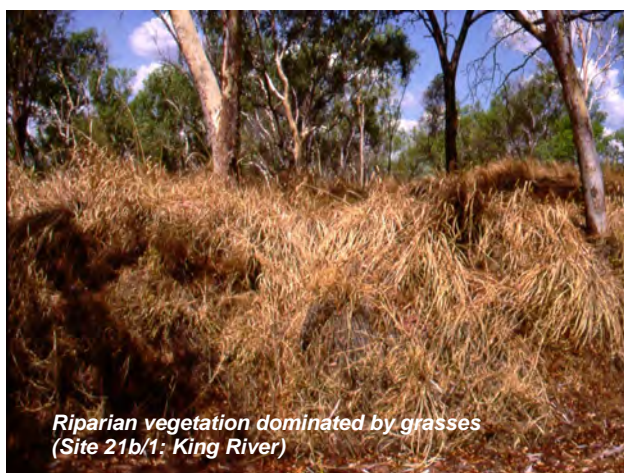
Riparian vegetation dominated by grasses  
(Site 21b/1: King River)

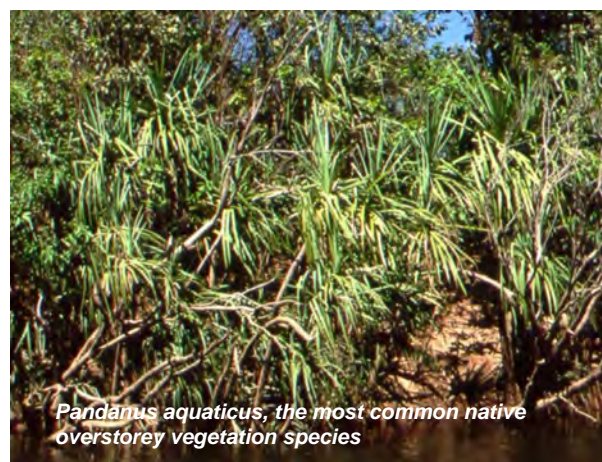
*Pandanus aquaticus*, the most common native overstorey vegetation species

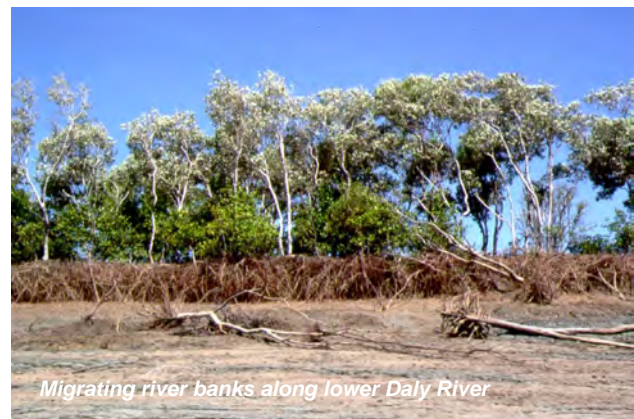
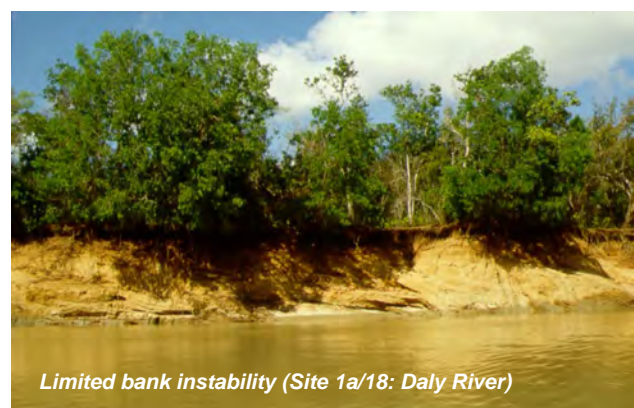
Figure 5.1 Changes in Channel Location along the Lower Tidal Section of Daly River

Those sites that recorded subjective bank stability ratings of moderate or moderate to high overall bank instability and susceptibility to erosion, were located on the Daly River (sites 1a/10, 1a/18 and 1a/19). Figure 5.1 shows the changes in channel location observed along the lower tidal section of the Daly River during field work in September 1995.

Downstream of site 1a/8 there were several outside bends that are migrating and the banks have eroding >1km since the topographic maps were produced in 1966. The banks along these sections are actively eroding and, as they collapse into the river, so does the riverine vegetation, which consists mostly of mangrove species. Refer Section 2.7 and Appendix A, which discusses the 'Evolution of the Daly River Estuarine Plains, noting how the river meanders along the tidal section of the Daly River are very actively migrating and the channel is "ever-changing".

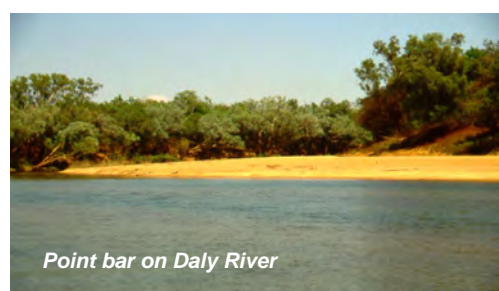
Point bar on Daly River

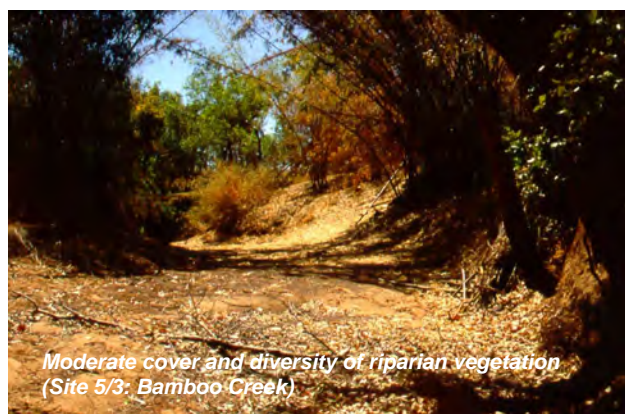
Moderate cover and diversity of riparian vegetation  
(Site 5/3: Bamboo Creek)

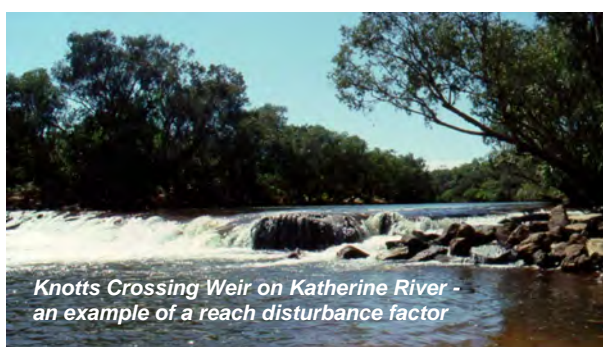
Knotts Crossing Weir on Katherine River - an example of a reach disturbance factor

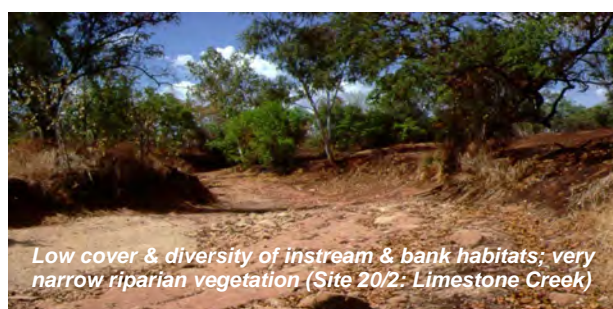
### *8. Instream and bank habitats were quite diverse and provided a fair degree of cover.*

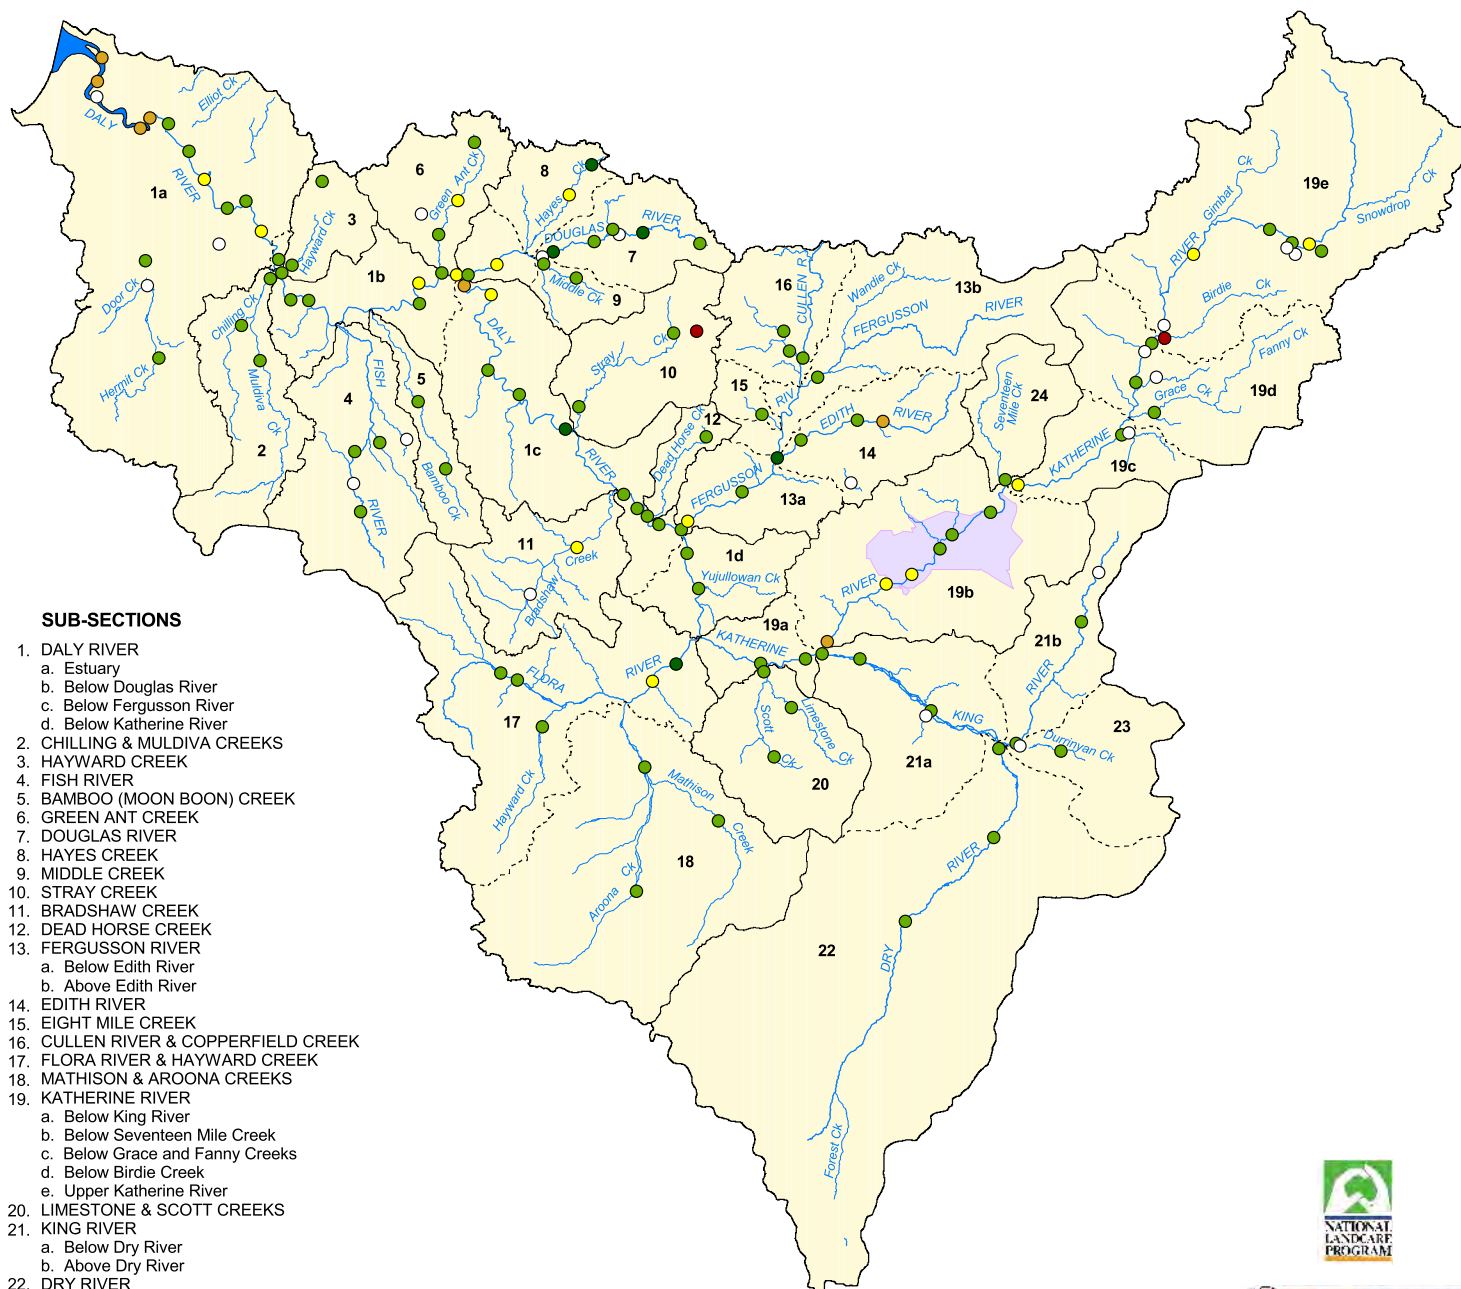
Map 11

# STATE OF THE REACH ENVIRONS

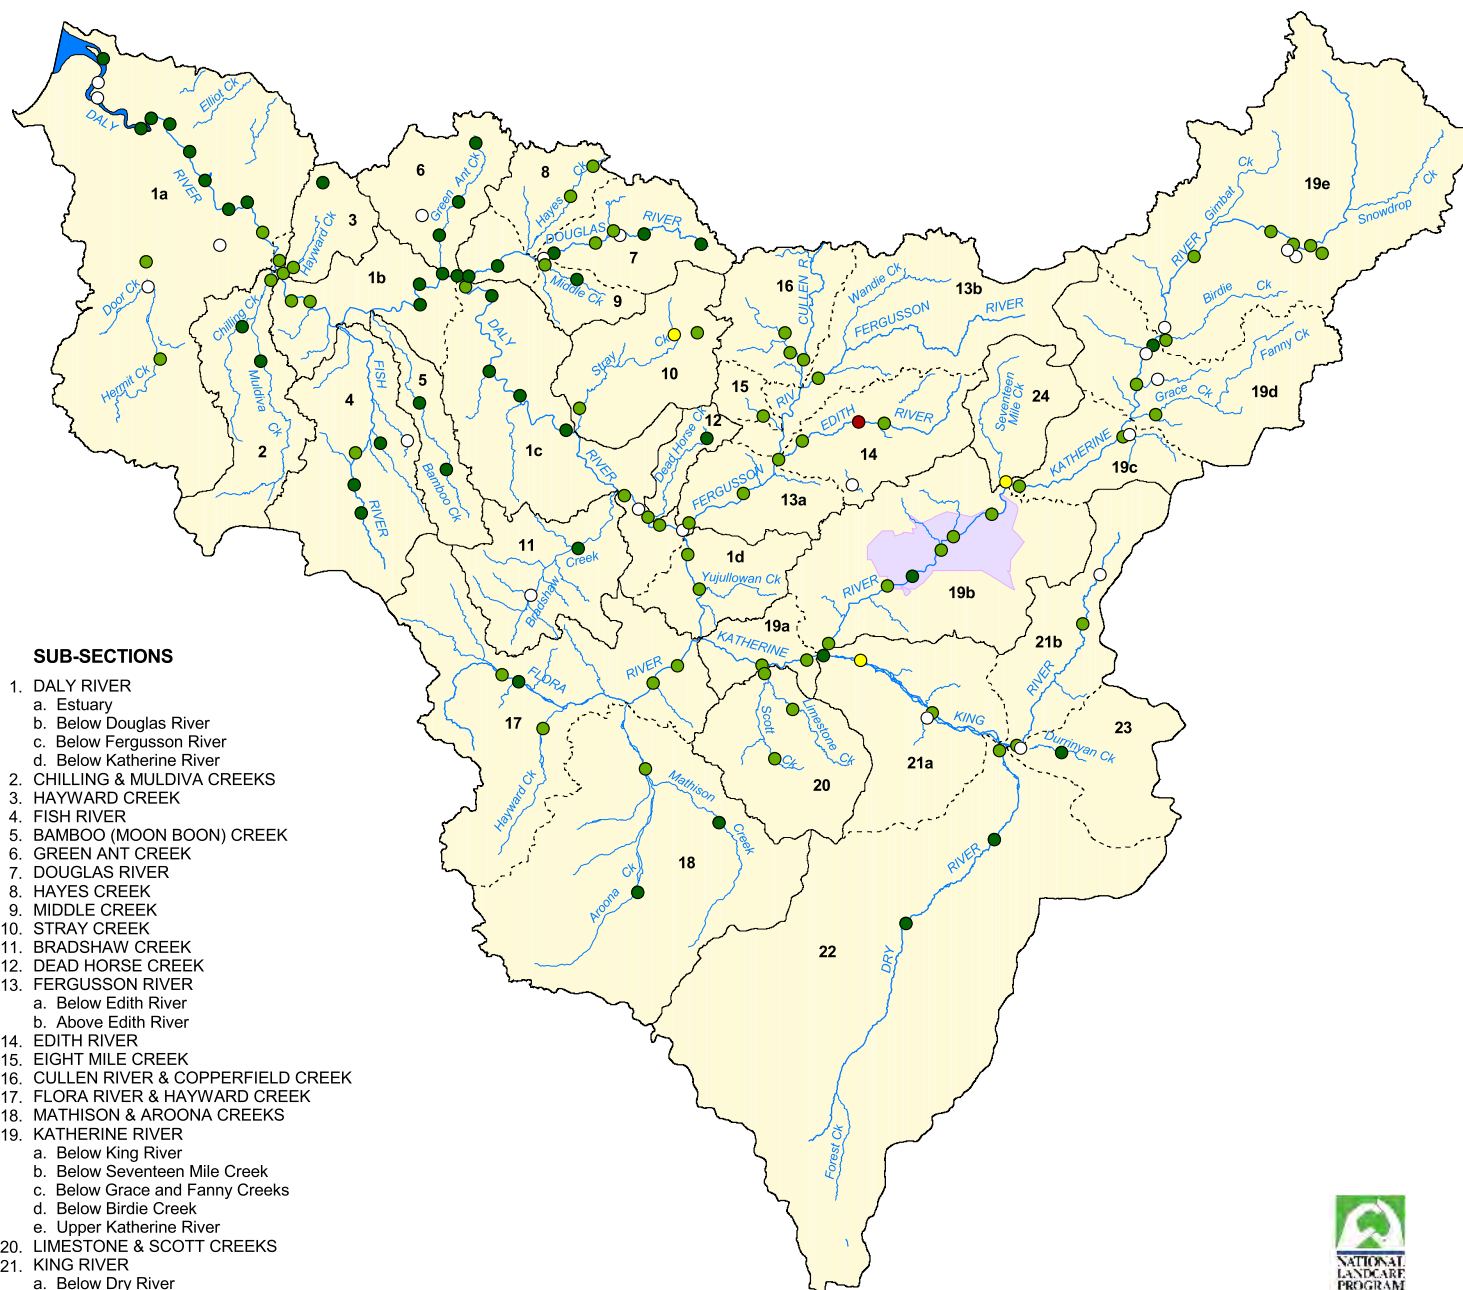
Map 17

## COVER OF EXOTIC RIPARIAN VEGETATION
