DALY RIVER CATCHMENT

An Assessment of the Physical and Ecological Condition of the Daly River and its Major Tributaries

Technical Report No TR99/10

July 1998

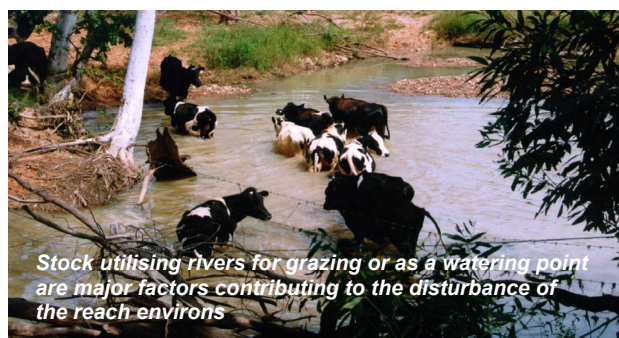
Subjective disturbance ratings indicated that nearly half the sites (48%) recorded a low disturbance level with respect to the reach environs (refer Table 4.3). A further 43.5% of sites were low to moderately disturbed. Few (2%) sites were highly disturbed and no sites were very highly to extremely disturbed.

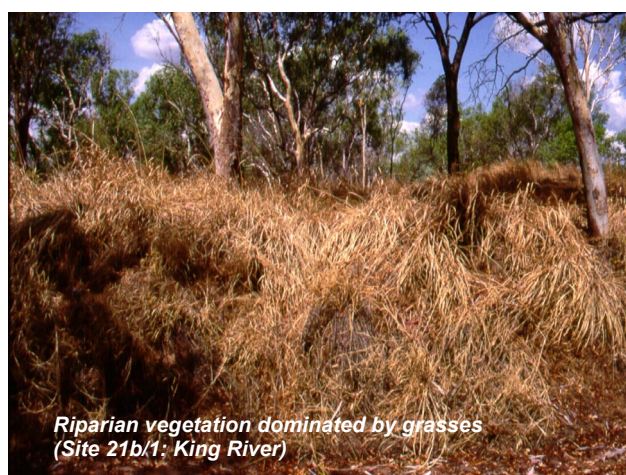
Riparian vegetation dominated by grasses
(Site 21b/1: King River)

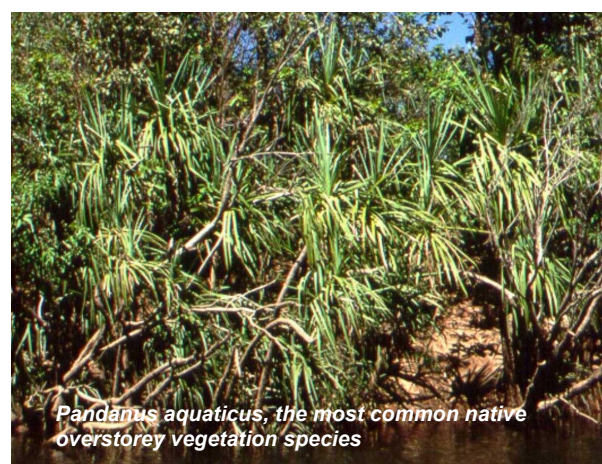
Pandanus aquaticus, the most common native overstorey vegetation species

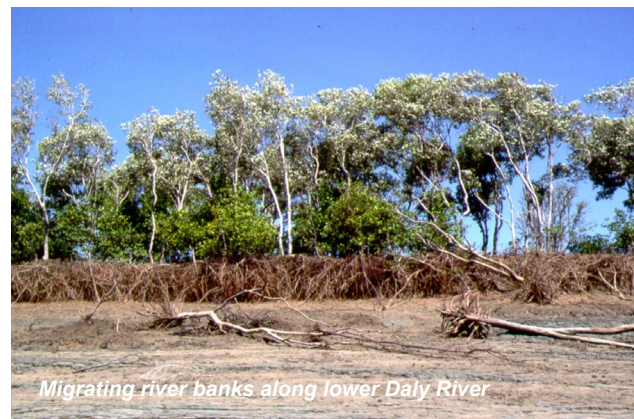
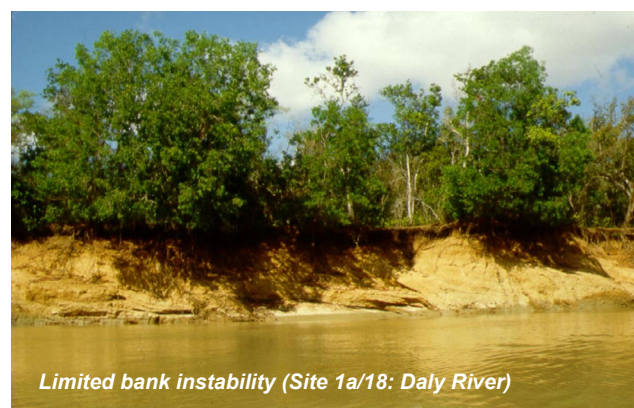
Figure 5.1 Changes in Channel Location along the Lower Tidal Section of Daly River

Those sites that recorded subjective bank stability ratings of moderate or moderate to high overall bank instability and susceptibility to erosion, were located on the Daly River (sites 1a/10, 1a/18 and 1a/19). Figure 5.1 shows the changes in channel location observed along the lower tidal section of the Daly River during field work in September 1995.

Downstream of site 1a/8 there were several outside bends that are migrating and the banks have eroding >1km since the topographic maps were produced in 1966. The banks along these sections are actively eroding and, as they collapse into the river, so does the riverine vegetation, which consists mostly of mangrove species. Refer Section 2.7 and Appendix A, which discusses the 'Evolution of the Daly River Estuarine Plains, noting how the river meanders along the tidal section of the Daly River are very actively migrating and the channel is "ever-changing".

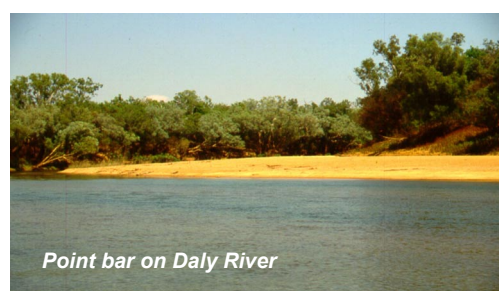
Point bar on Daly River

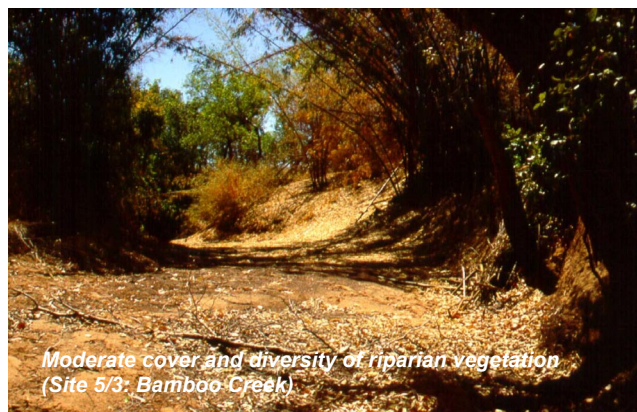
Moderate cover and diversity of riparian vegetation
(Site 5/3: Bamboo Creek)

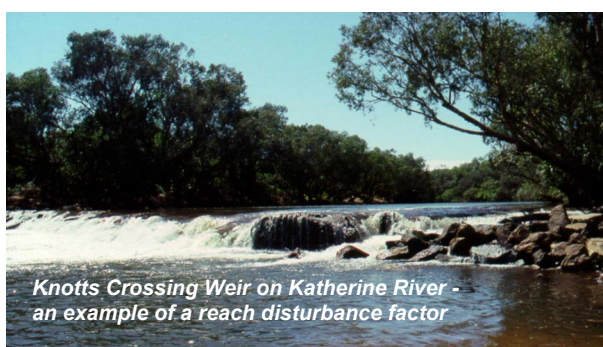
Knotts Crossing Weir on Katherine River - an example of a reach disturbance factor

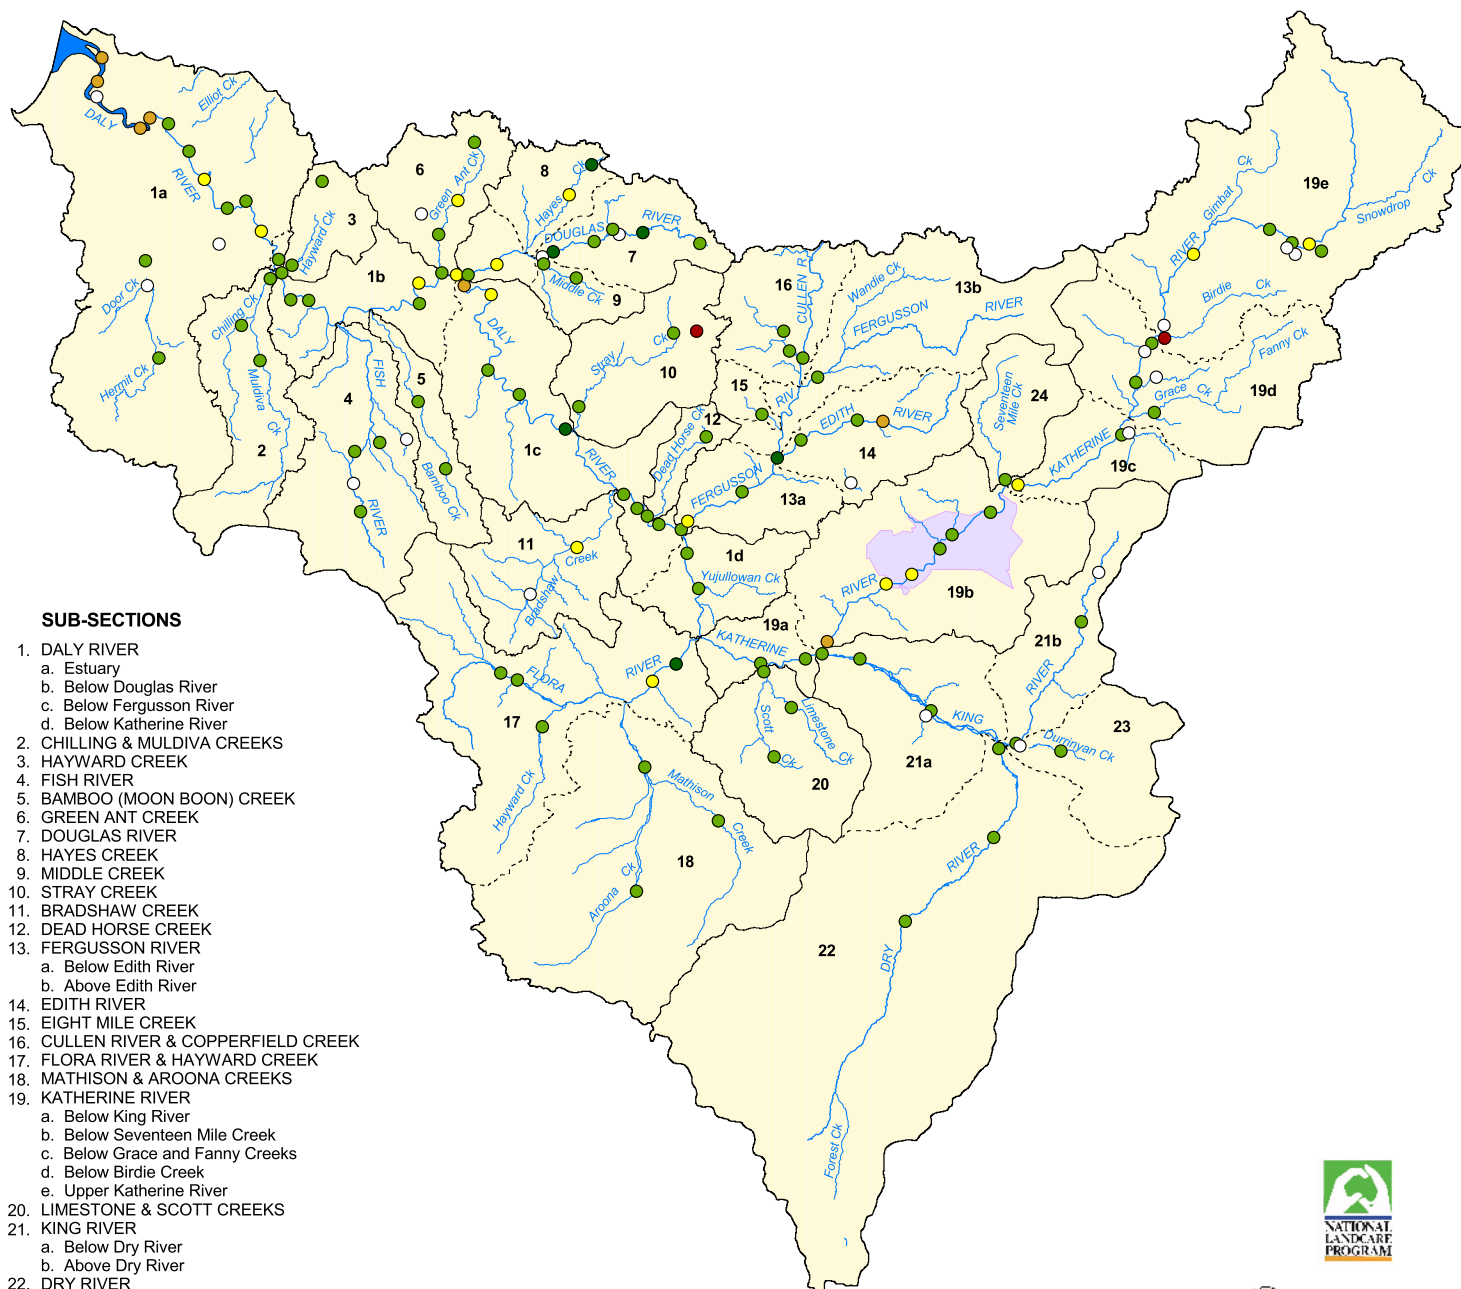
Map 11

STATE OF THE REACH ENVIRONS
